# TOWN OF JACKSON

#### TRANSMITTAL MEMO

The applicant is submitting a request for a Hillside CUP for Physical Development on a parcel with slopes in excess of 10%. The property is located on 1255 W. Highway 22. In addition, the applicant seeks to amend their previously approved Development Agreement.

**GEOTECHNICAL INVESTIGATION REPORT  
WEST VIEW TOWNHOMES  
1255 W HIGHWAY 22  
JACKSON, WYOMING**

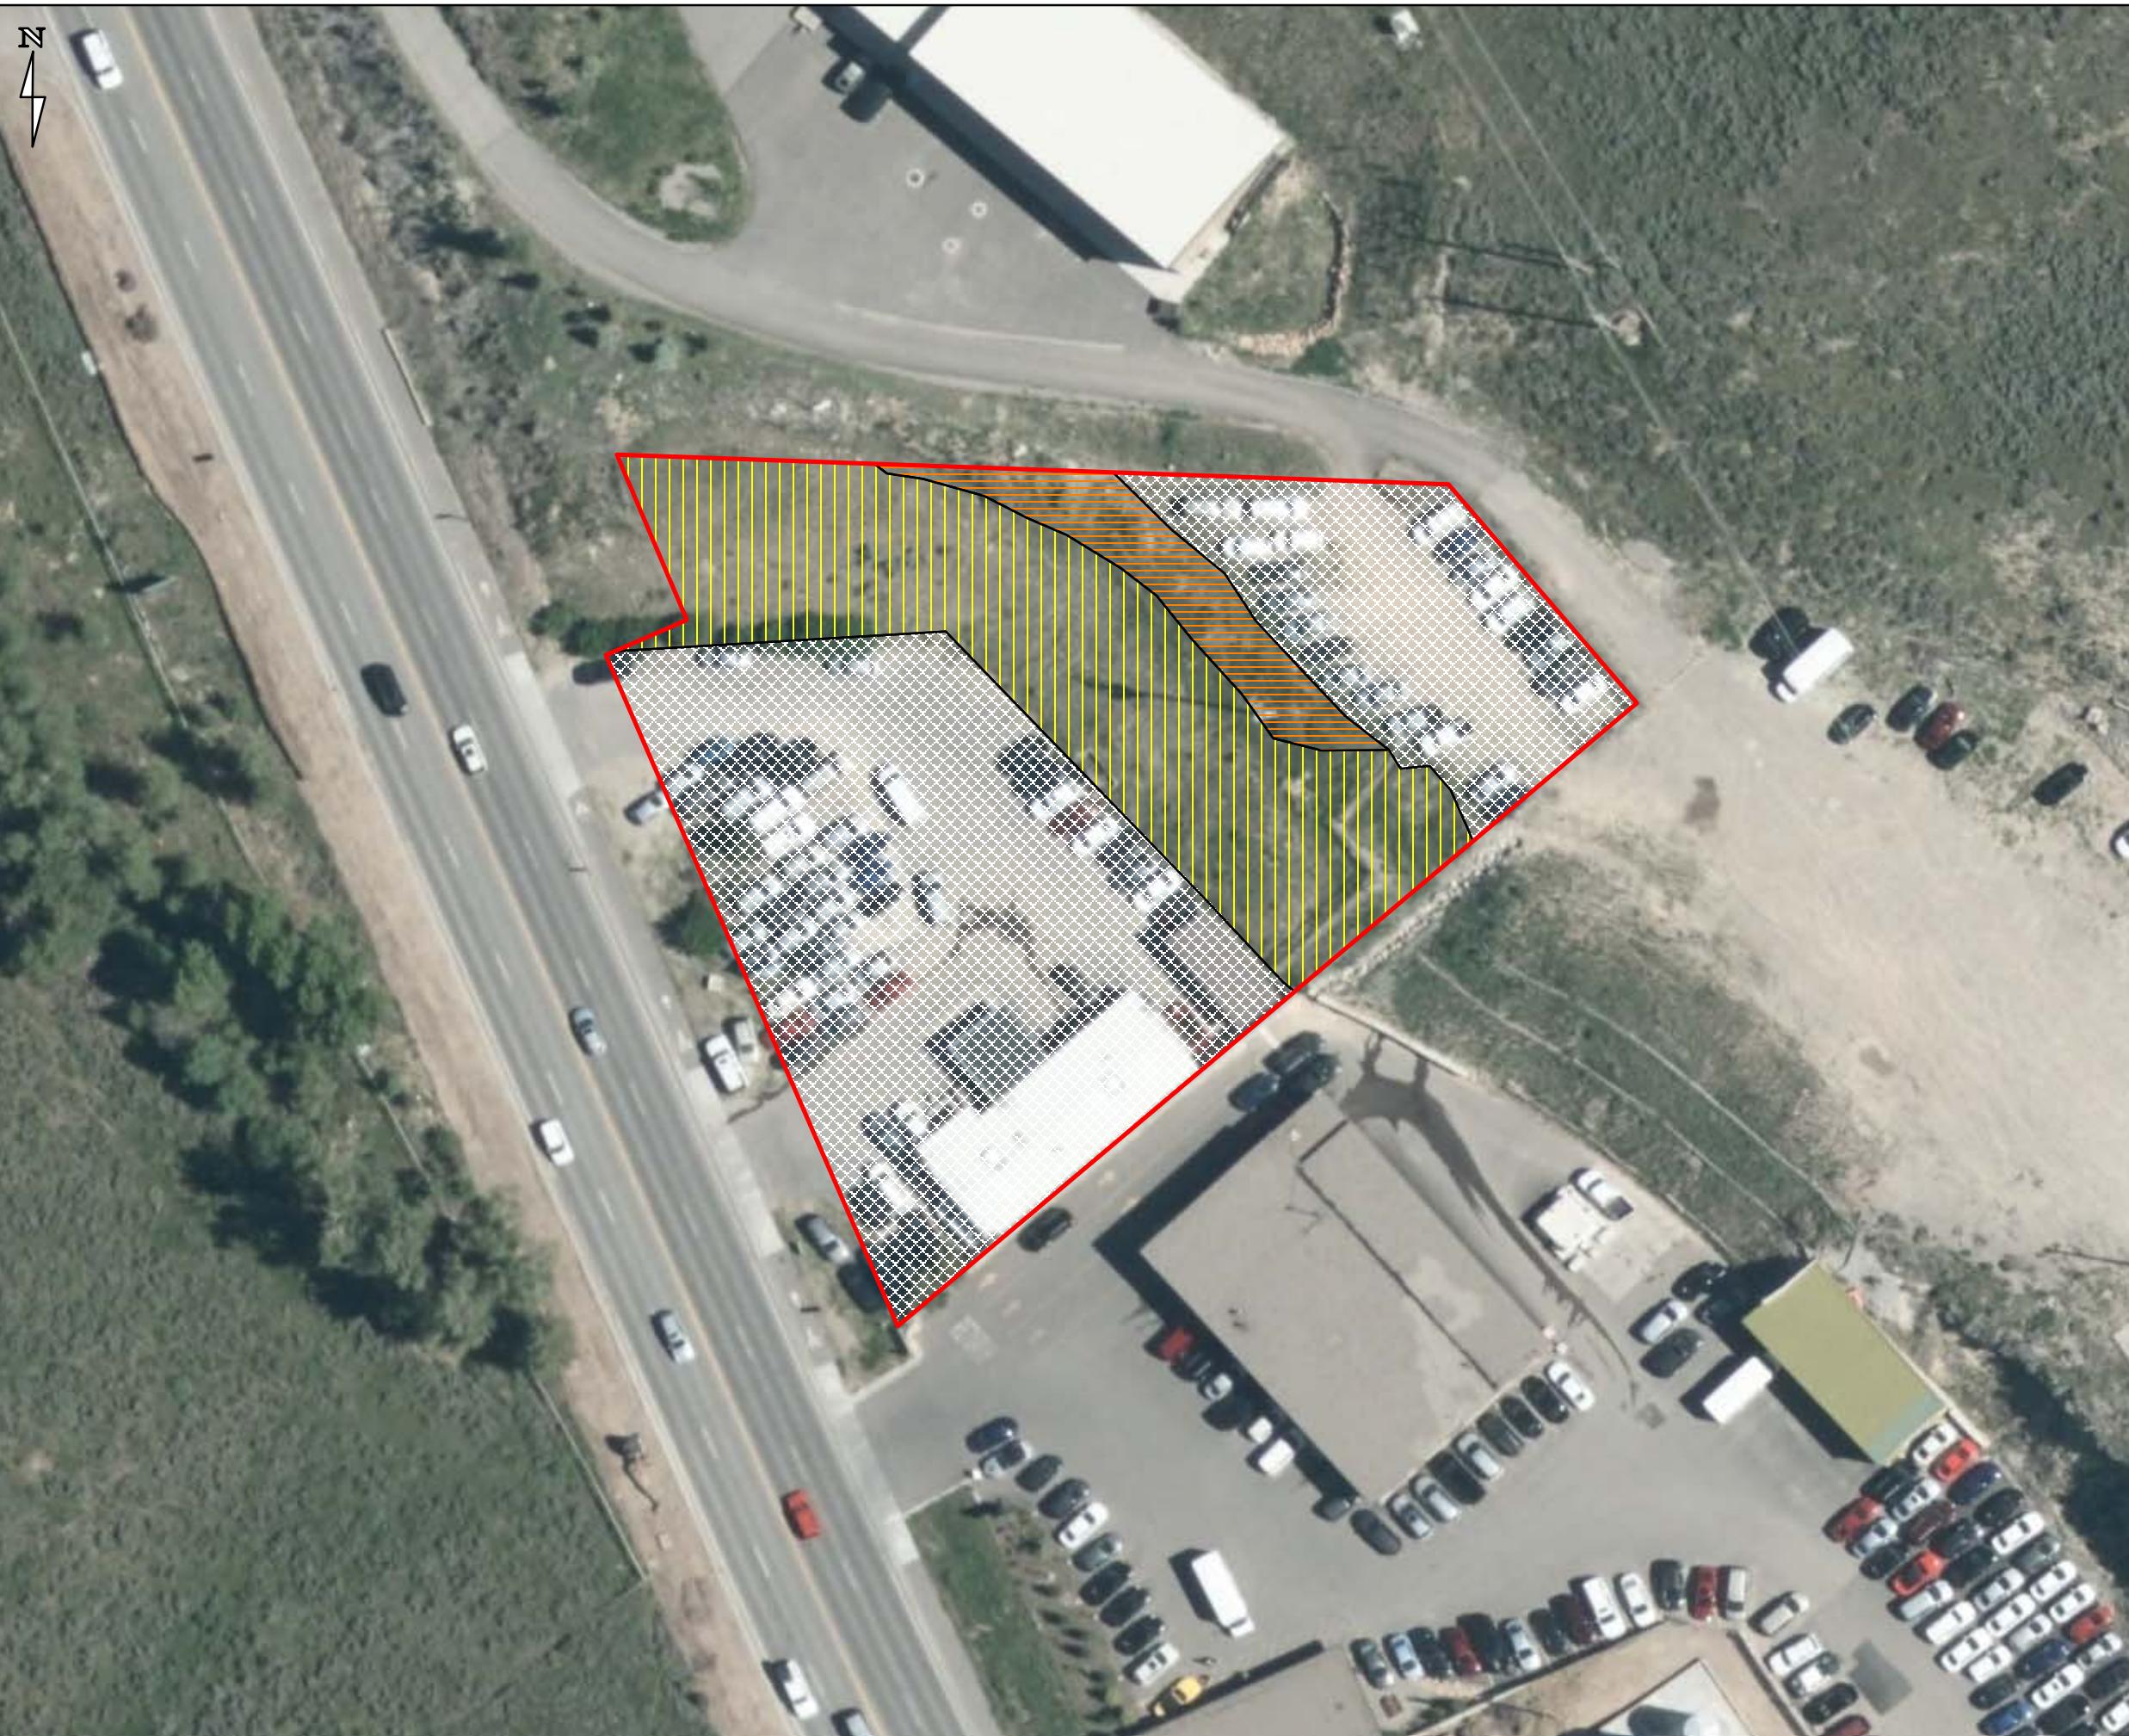
Attachment 2  
Aerial photograph depicting vegetative  
covertypes within the Westview Town Homes  
property in Jackson, Teton County, Wyoming.

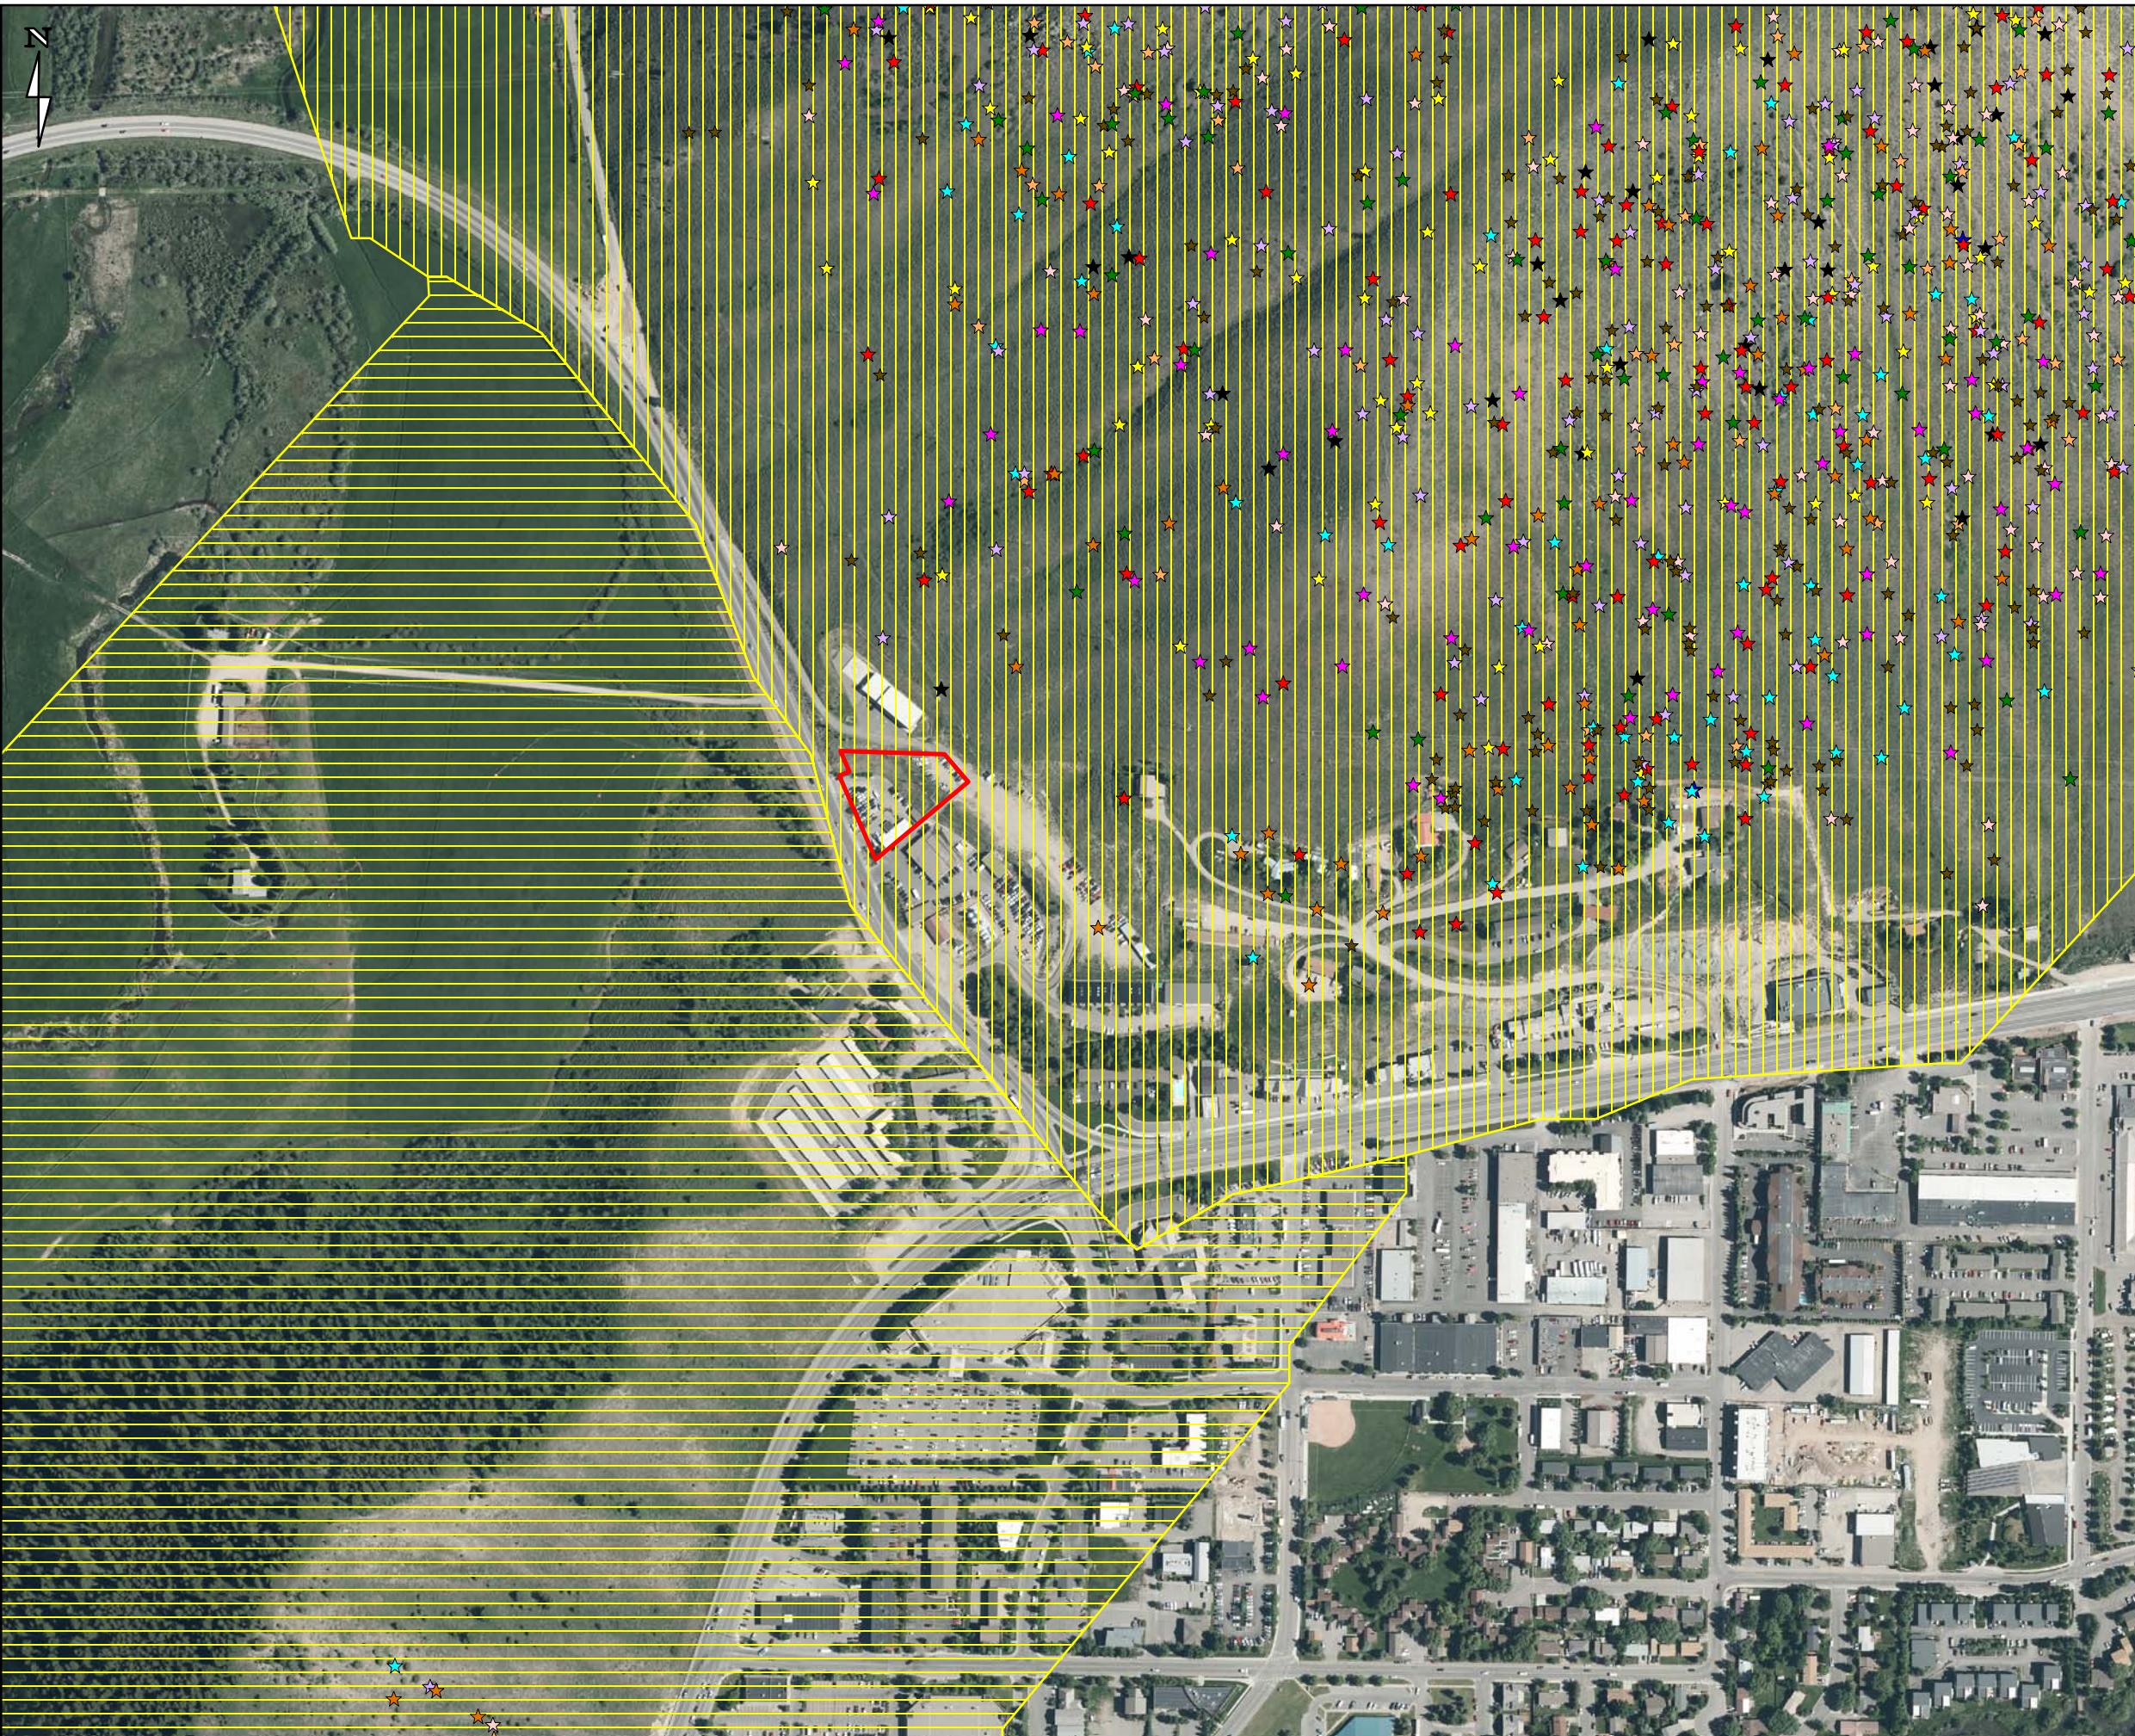
Attachment 3  
Aerial photograph depicting mapped mule deer habitat and historic observations on and in the vicinity of the Westview Town Homes property in Jackson, Teton County, Wyoming.

Thirteen years of data collected during a winter mule deer study on East Gros Ventre Butte by Biota (1979-1994) and additional data collected by the Conservation Research Center (Teton Science School) showed that deer were not observed within the project area (Appendix 1-Exhibit 3). Three mule deer groups were observed in proximity to the project area at higher elevations during nearly 20 years of data collection.

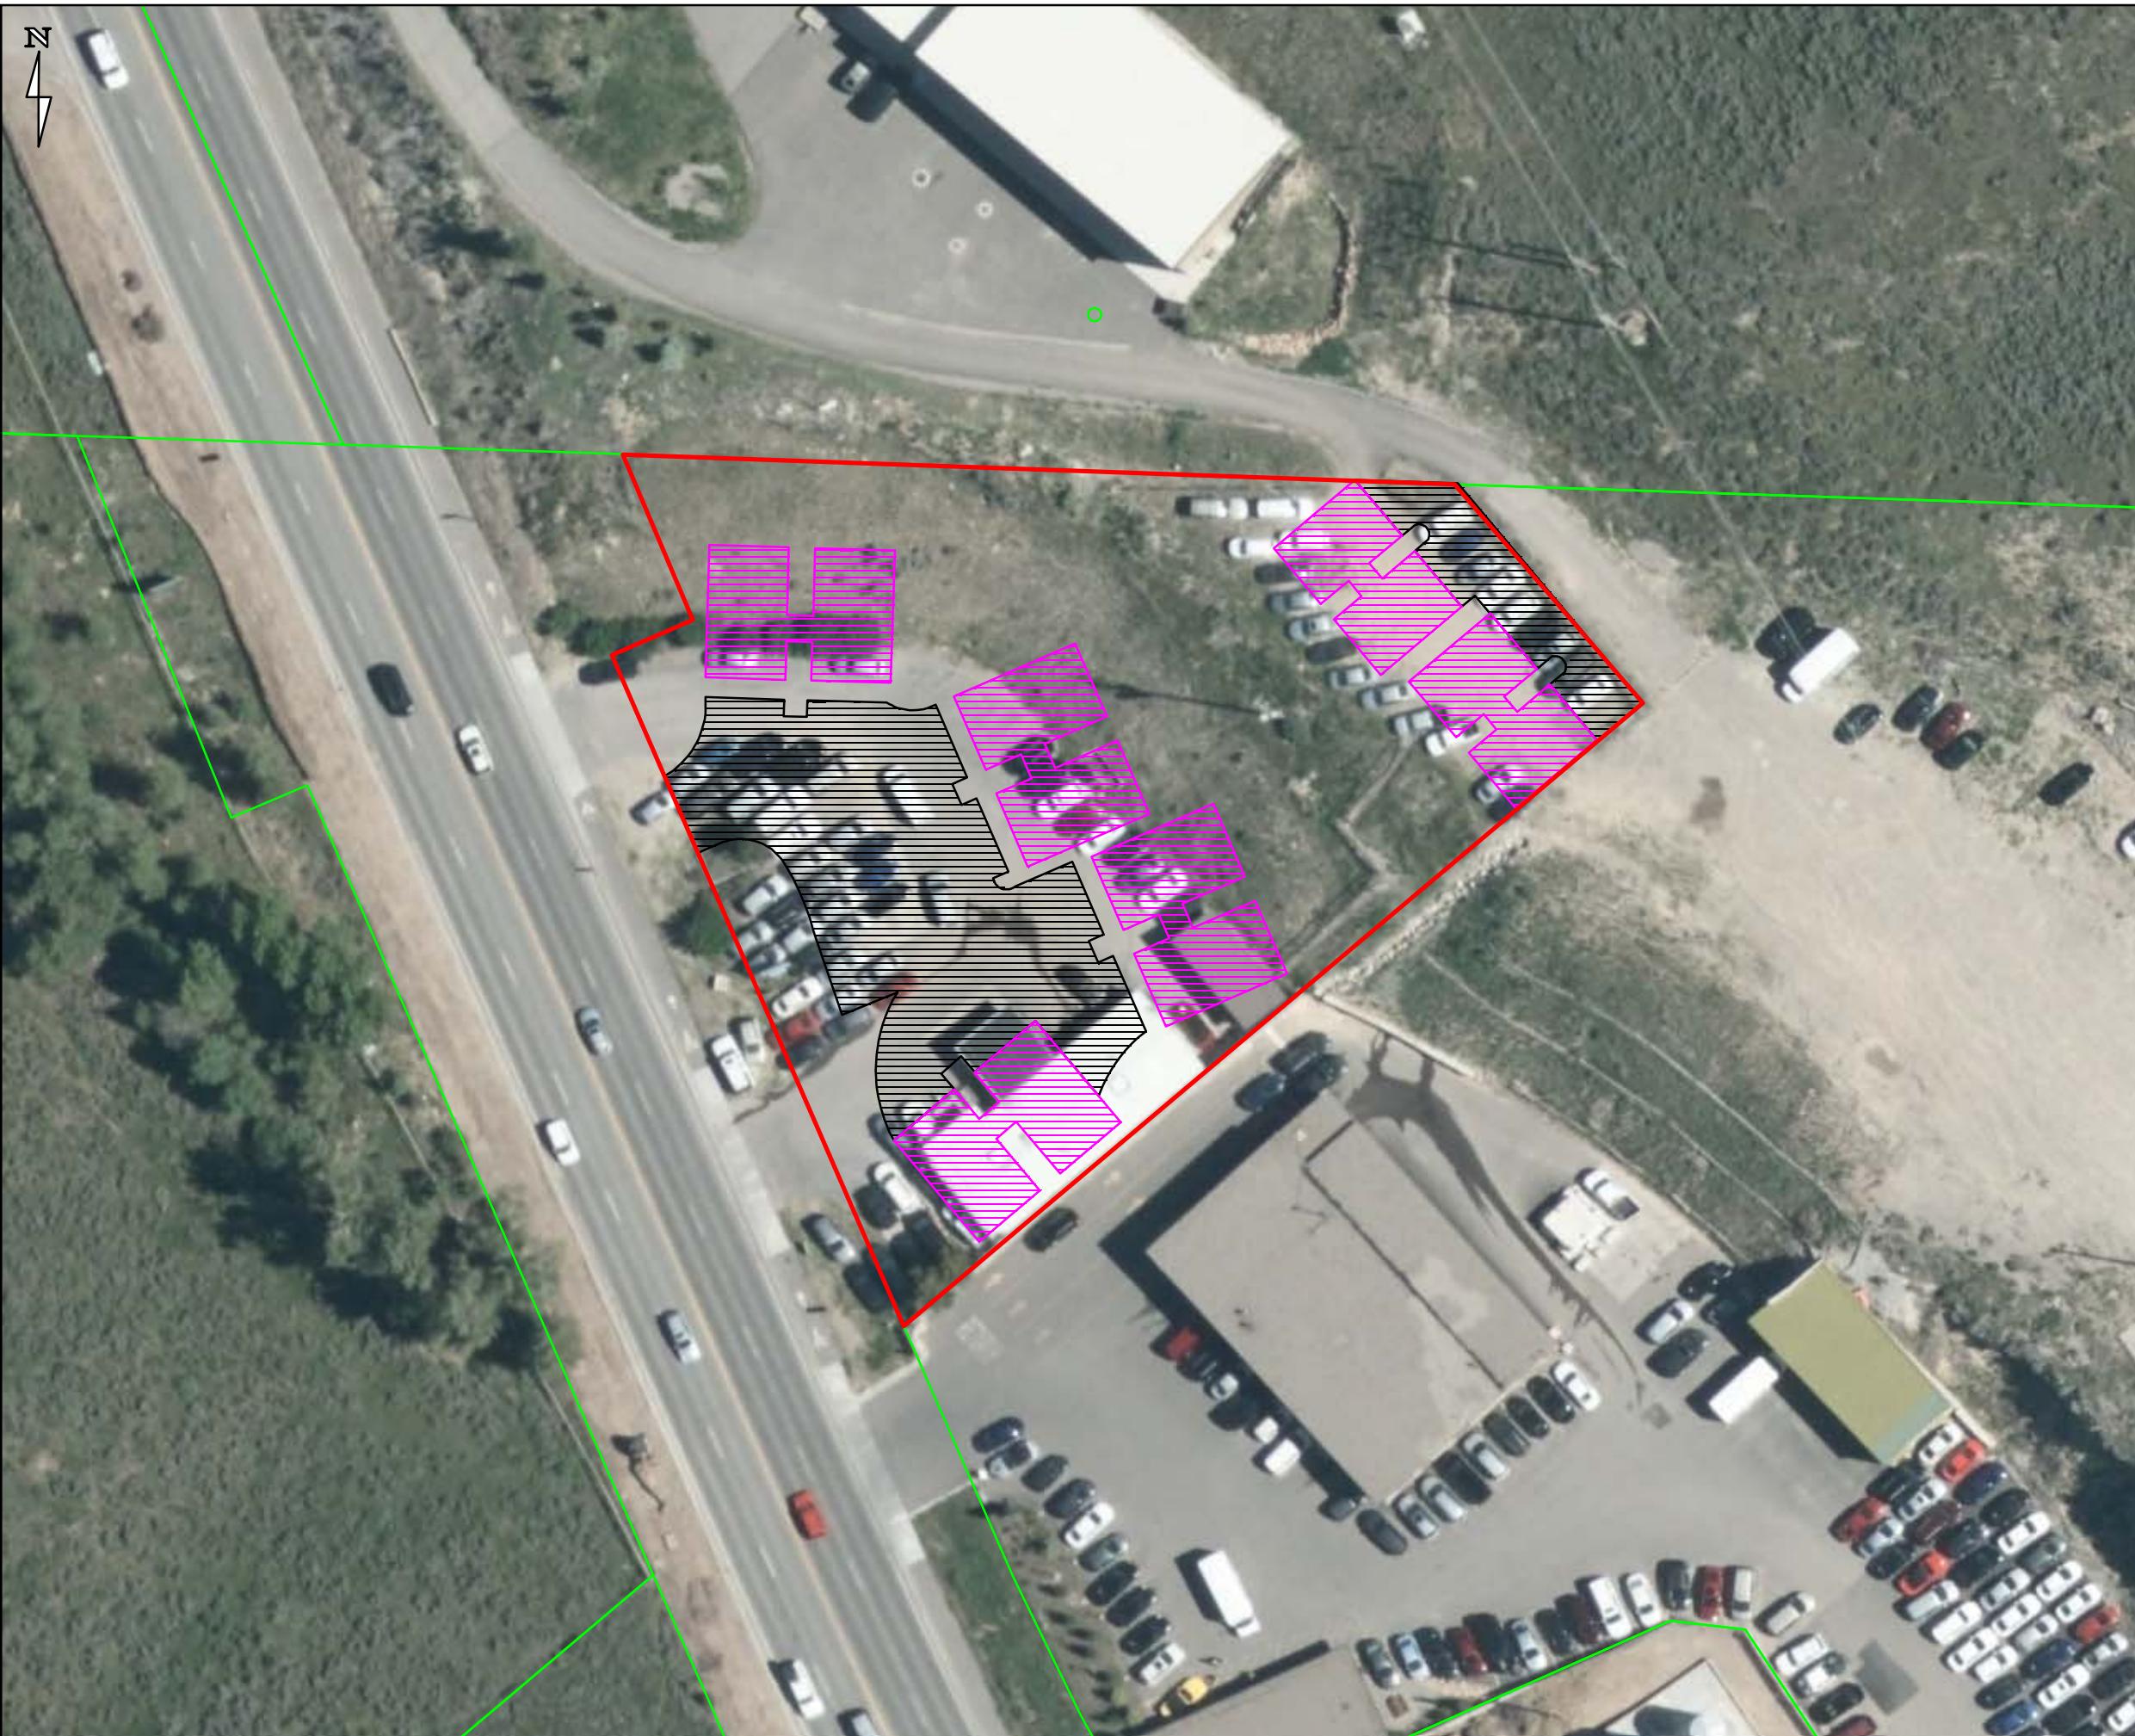
Exhibit 4  
Aerial photograph depicting proposed development within the Westview Town Homes property in Jackson, Teton County, Wyoming.

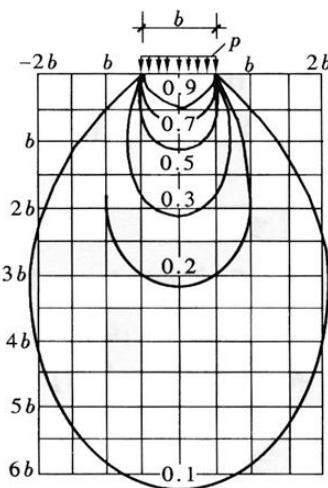
**Figure 1: Boussinesq Vertical Stress Distribution below Continuous Footing**

*Although assuming foundation pressures induced on underlying soil follow a linear distribution of 0.5H:1V, often referred to as the "2:1 Method", it is not the only approach to estimate pressures applied to soil by foundation elements. Boussinesq stress distributions, based on elasticity theory, have more of a "bulb" shape. The figure below shows the pressure distributions for a strip footing of width = b. As is shown in the figure, a pressure equipotential line equivalent to 30% of the foundation pressure (0.3p) extends to an approximate depth of 2b, commonly referred to as the foundation's "zone of influence", and only extends laterally to approximately 0.75b from the center of the footing. Therefore, in our opinion, requiring the excavation to extend the lateral distances suggested by LT is not necessary.*

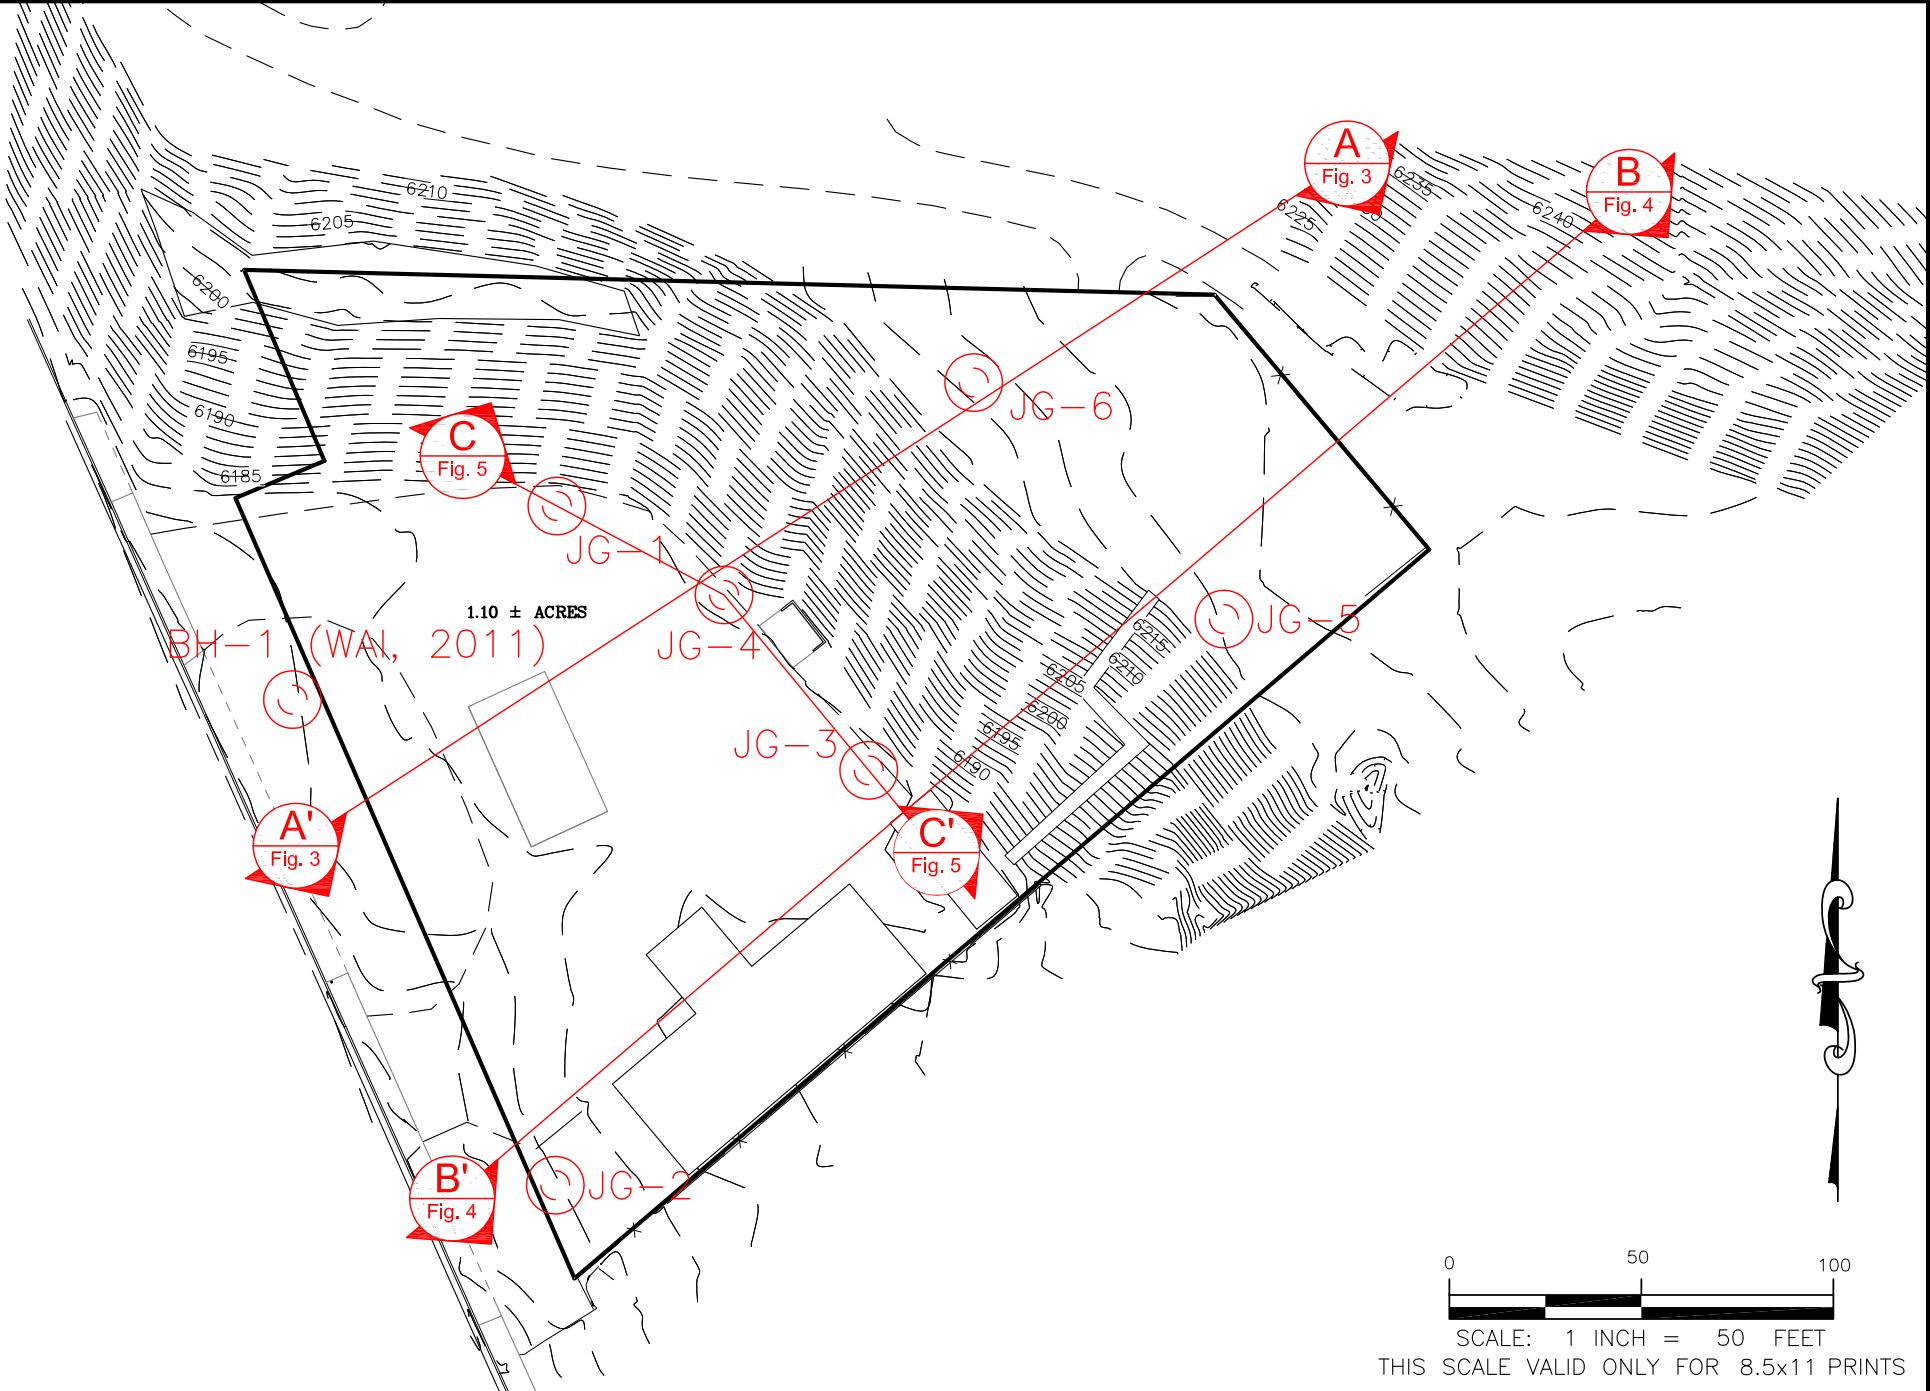
SHEET TITLE:  
**FIGURE 2**  
BOREHOLE AND CROSS-SECTION  
LOCATION MAP

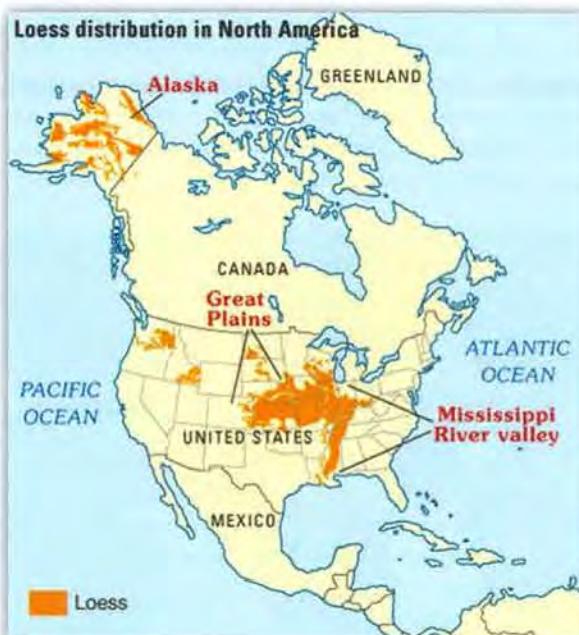
Figure 2. Loess distribution in North America (courtesy of U.S. Geological Survey).

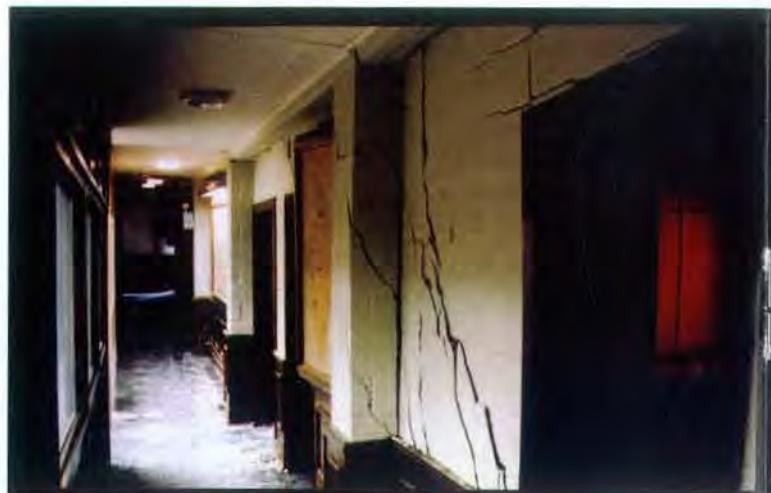
Figure 4. Building damage due to loess collapse.

Collapse of loess soils due purely to increased loading is rare, as the bearing pressures of foundations supported on dry loess are generally limited to pressures much below the bearing capacity of the in-situ strength of the soil. Collapse/settlement of loess is predominantly related to wetting of the soils, which breaks down the weak bonding created by the clay or mineral paste surrounding the silt and sand particles.

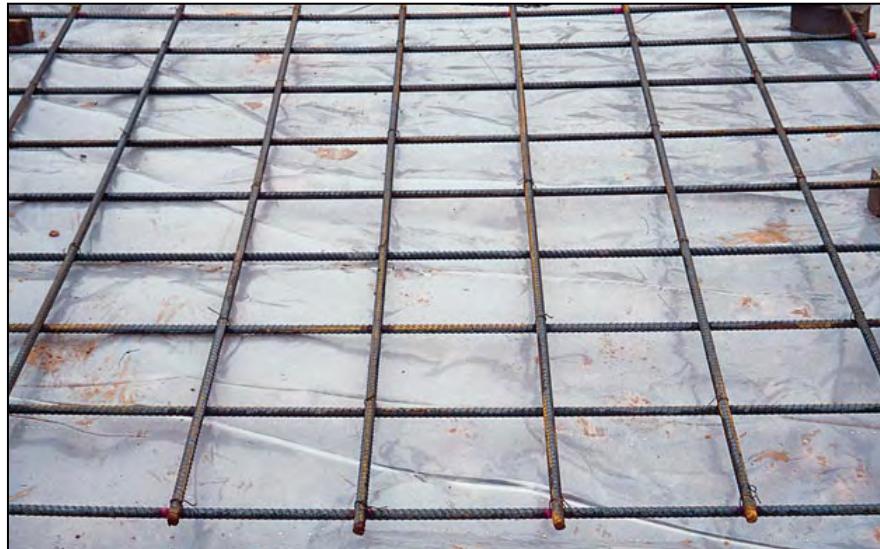
Rebar in concrete slabs placed directly on a vapor retarder help to control slab curling and cracking. Use supported deformed bars no smaller than #4, and space the bars far enough apart so workers can step between them.

Typically, I specify #4 bars spaced 18 inches on center both ways. This amount of steel holds crack faces together tightly enough for nonrigid floor coverings by maintaining aggregate interlock and significantly reducing slab curling. In some instances, closer spacing or larger-diameter bars may be needed. Constructability becomes an issue when bar spacing is so close that workers

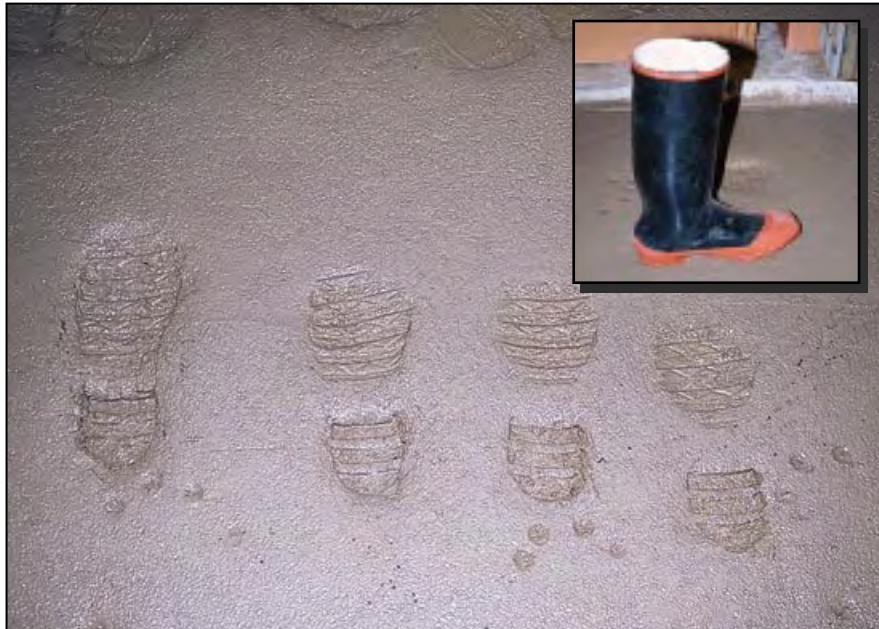
Figure 1. Concrete is generally considered to be ready for floating when finishers leave a ¼-inch-deep footprint in the surface. Using a boot filled with steel shot (inset) to produce footprints, we found that 2½-inch-slump concrete placed on a stone base was ready for floating about 45 minutes earlier than the same concrete placed directly on a vapor retarder.

tarder and the other on a crushed-stone base. Technicians periodically set a steel-shot-filled rubber boot weighing 75 pounds on the surface and measured the footprint indentation (Fig. 1). Concrete on the stone base had stiffened enough after 90 minutes to allow a ¼-inch footprint

indentation, an indication that floating could begin. Concrete placed directly on the vapor retarder required 45 more minutes of stiffening time before it was ready for floating.

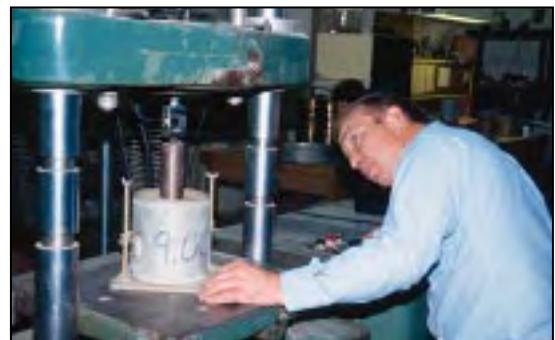
Figure 1. A technician applies load to a compacted soil specimen in a CBR mold. Specimens were loaded with and without sand layers to determine the effect of differing sand-layer thicknesses.

To assess the effect of a thin, loose sand layer on subgrade support, we performed duplicate California Bearing Ratio tests (see "What's a CBR Test") using three soil samples with varying dry densities. Each test specimen was tested with no sand, a 1-inch sand layer and a 2-inch sand layer. In addition, we placed 1- and 2-inch sand layers over a steel base and tested that combination to show how the sand would affect subgrade support over a very stiff base.

To start the test, a technician placed the soil into a 6-inch-diameter cylinder mold and compacted it. After compaction, he removed the top extension collar and trimmed the soil to a 4½-inch height. He then inverted the mold and added a 10-pound surcharge weight to the top
