TOWN OF JACKSON

SUBJECT: **ITEMS P18-095, P18-135 & P18-136:** REQUEST FOR AMENDMENT OF DEVELOPMENT PLAN, AMENDMENT TO DEVELOPMENT AGREEMENT & APPROVAL OF A HILLSIDE CONDITIONAL USE PERMIT (CUP) FOR THE WESTVIEW TOWNHOMES ADDRESSED AT 1255 WEST HIGHWAY 22.

**-ENVIRONMENTAL ANALYSIS-
WESTVIEW TOWN HOMES PROJECT,
JACKSON, WYOMING**

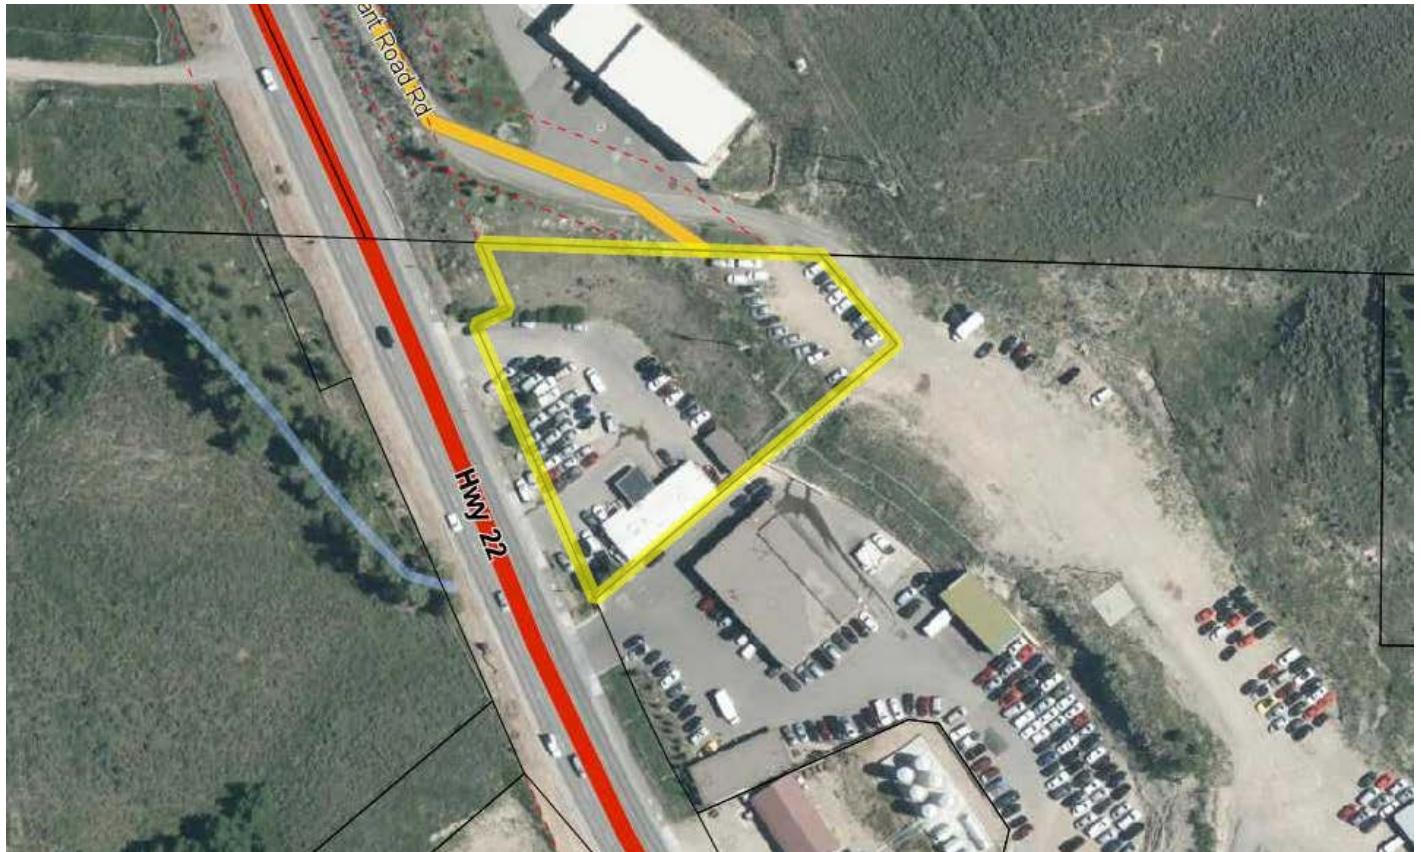
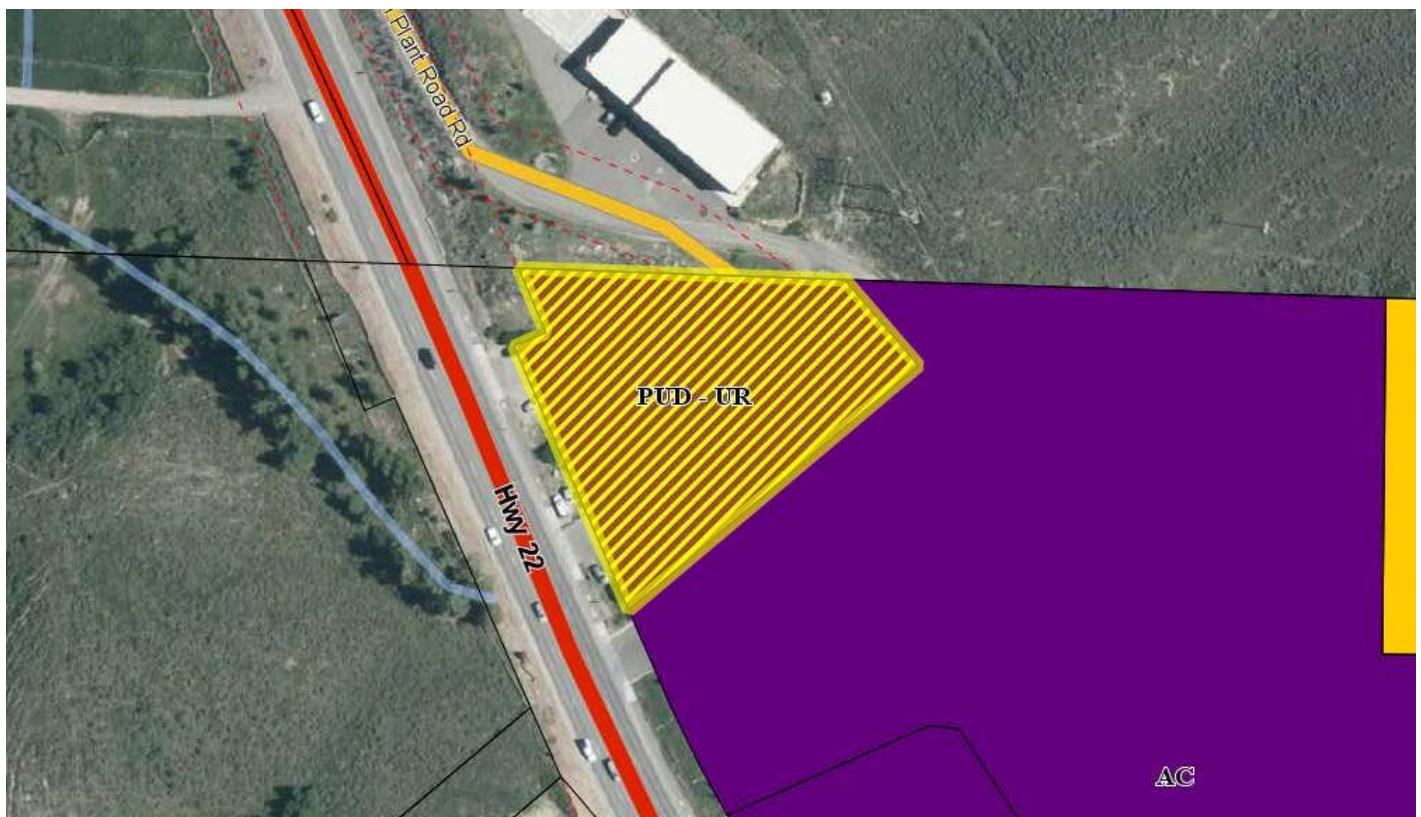
The property is located at 1255 West Highway 22, legally described as PT SW1/4NE1/4, Section 32, Township 41, Range 116. An aerial photo and zoning map are shown below:

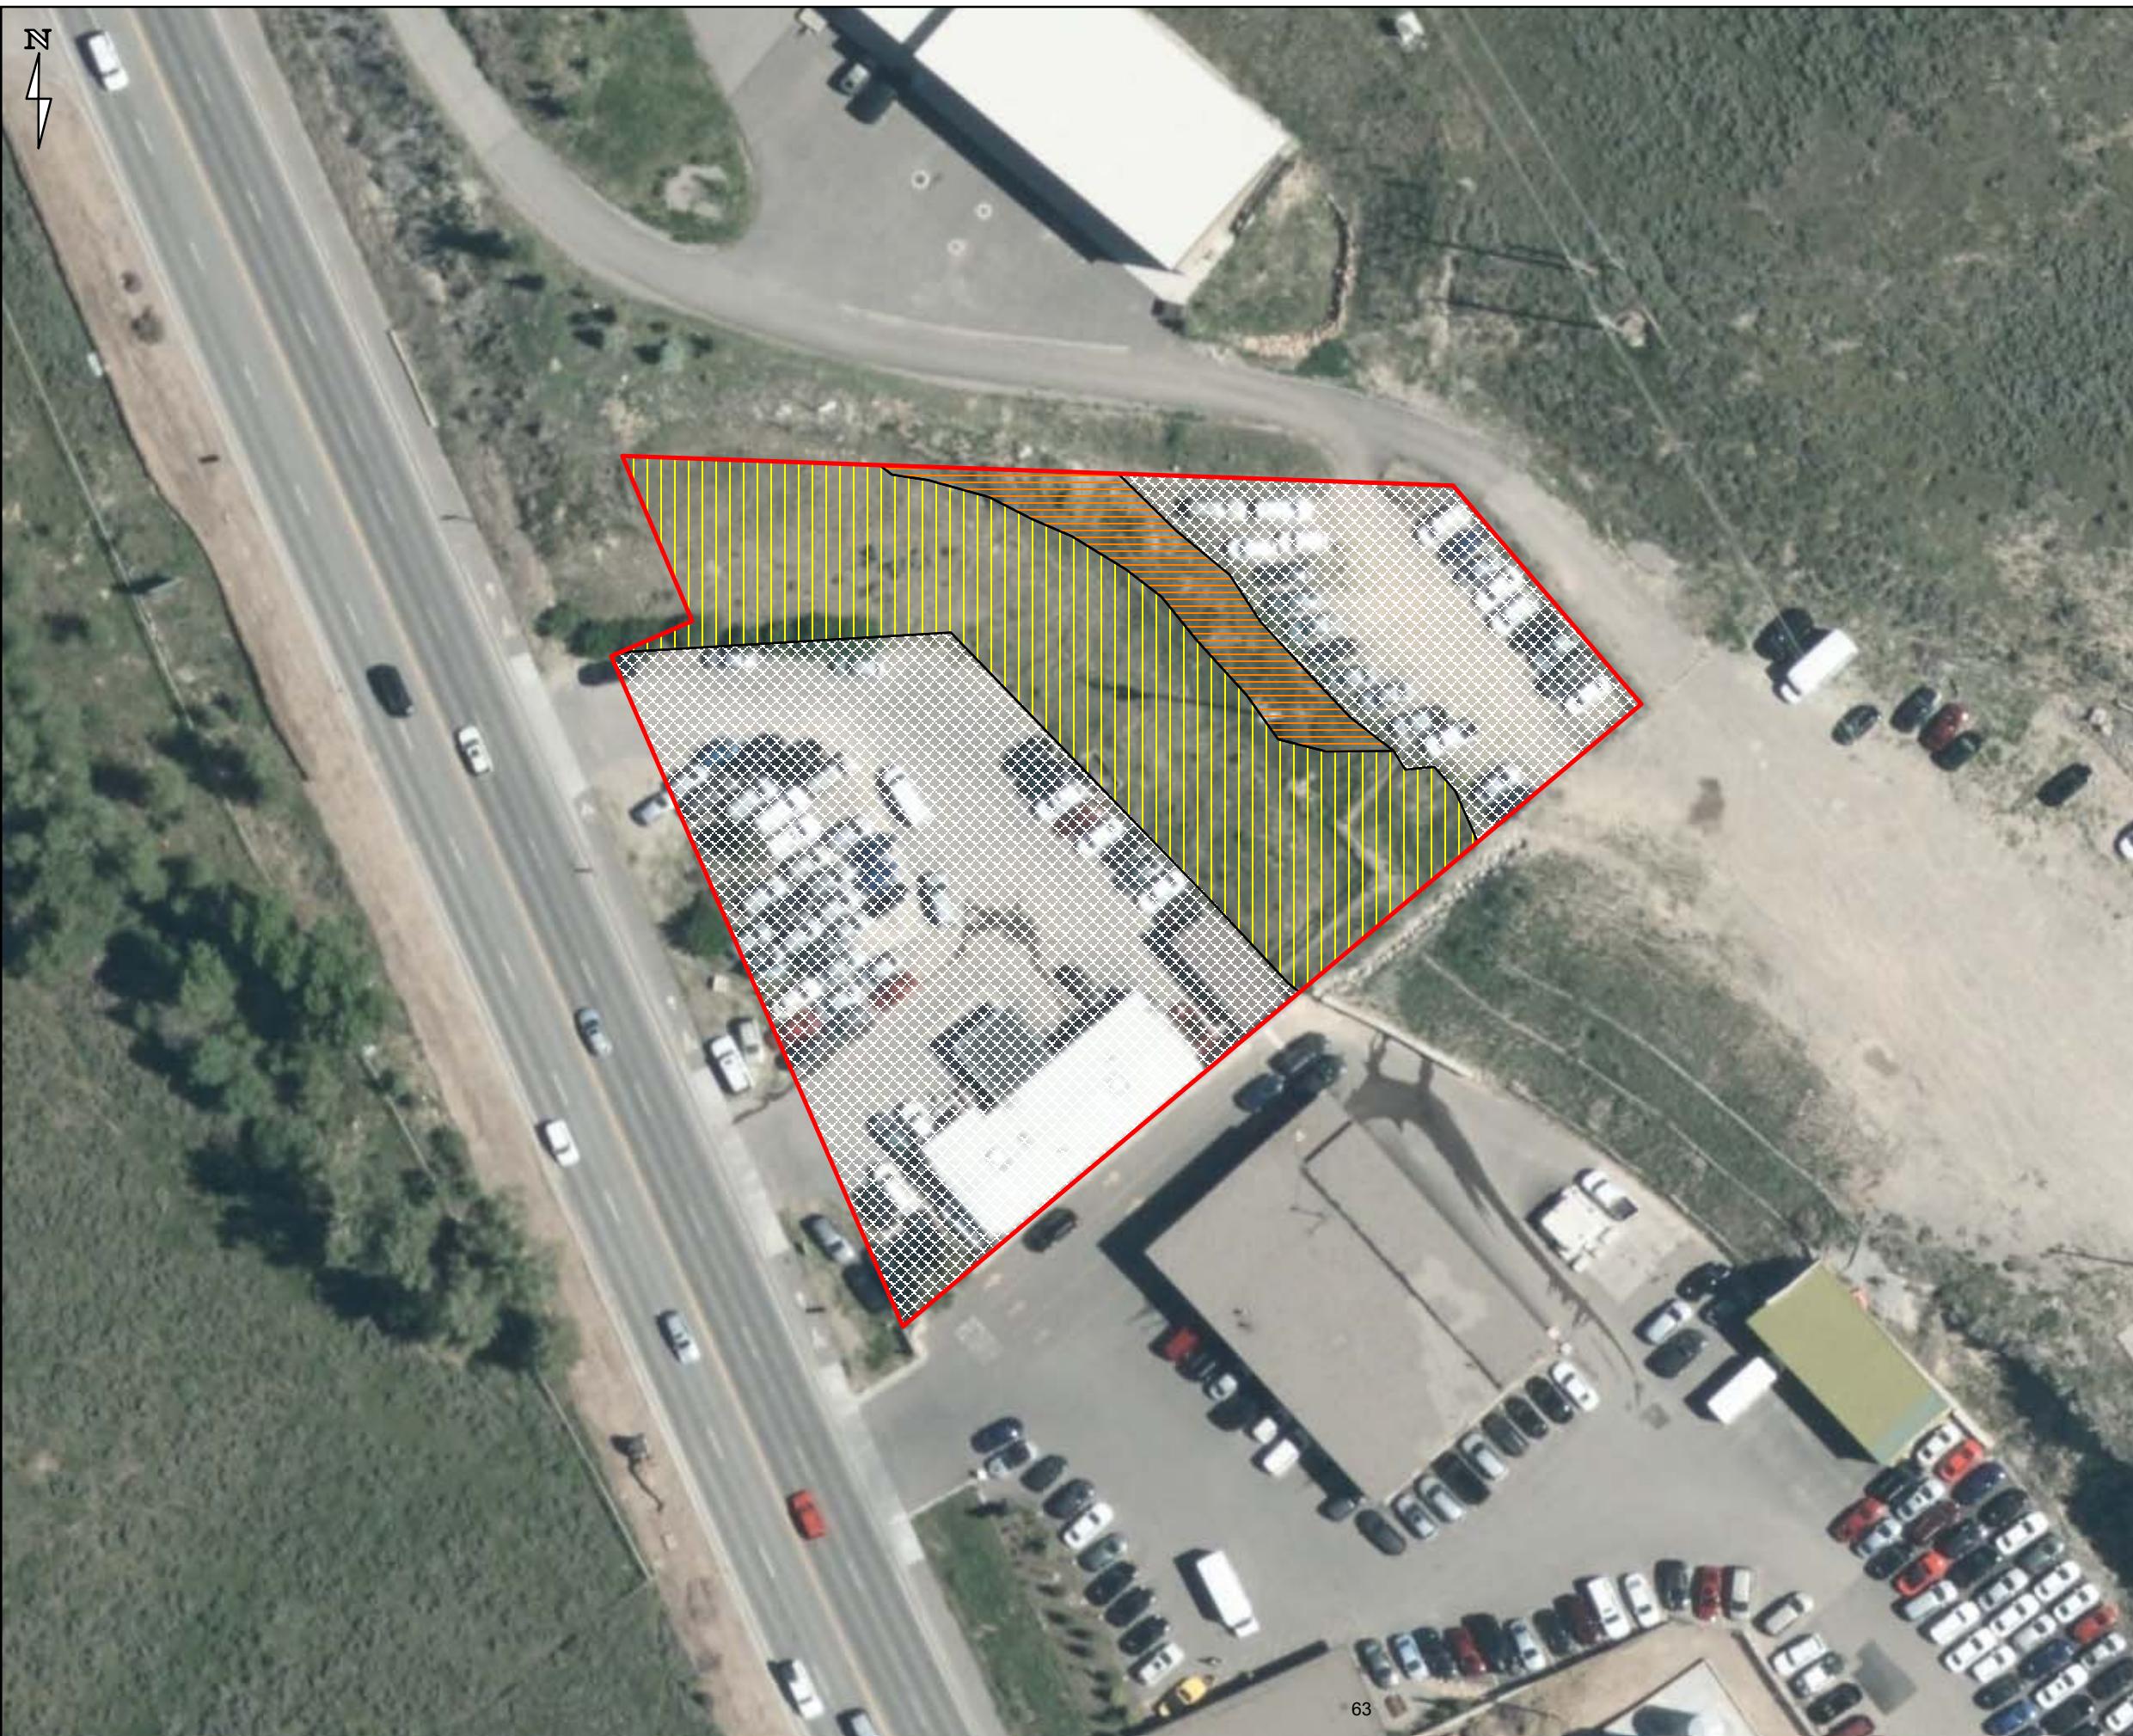
Attachment 2
Aerial photograph depicting vegetative
covertypes within the Westview Town Homes
property in Jackson, Teton County, Wyoming.

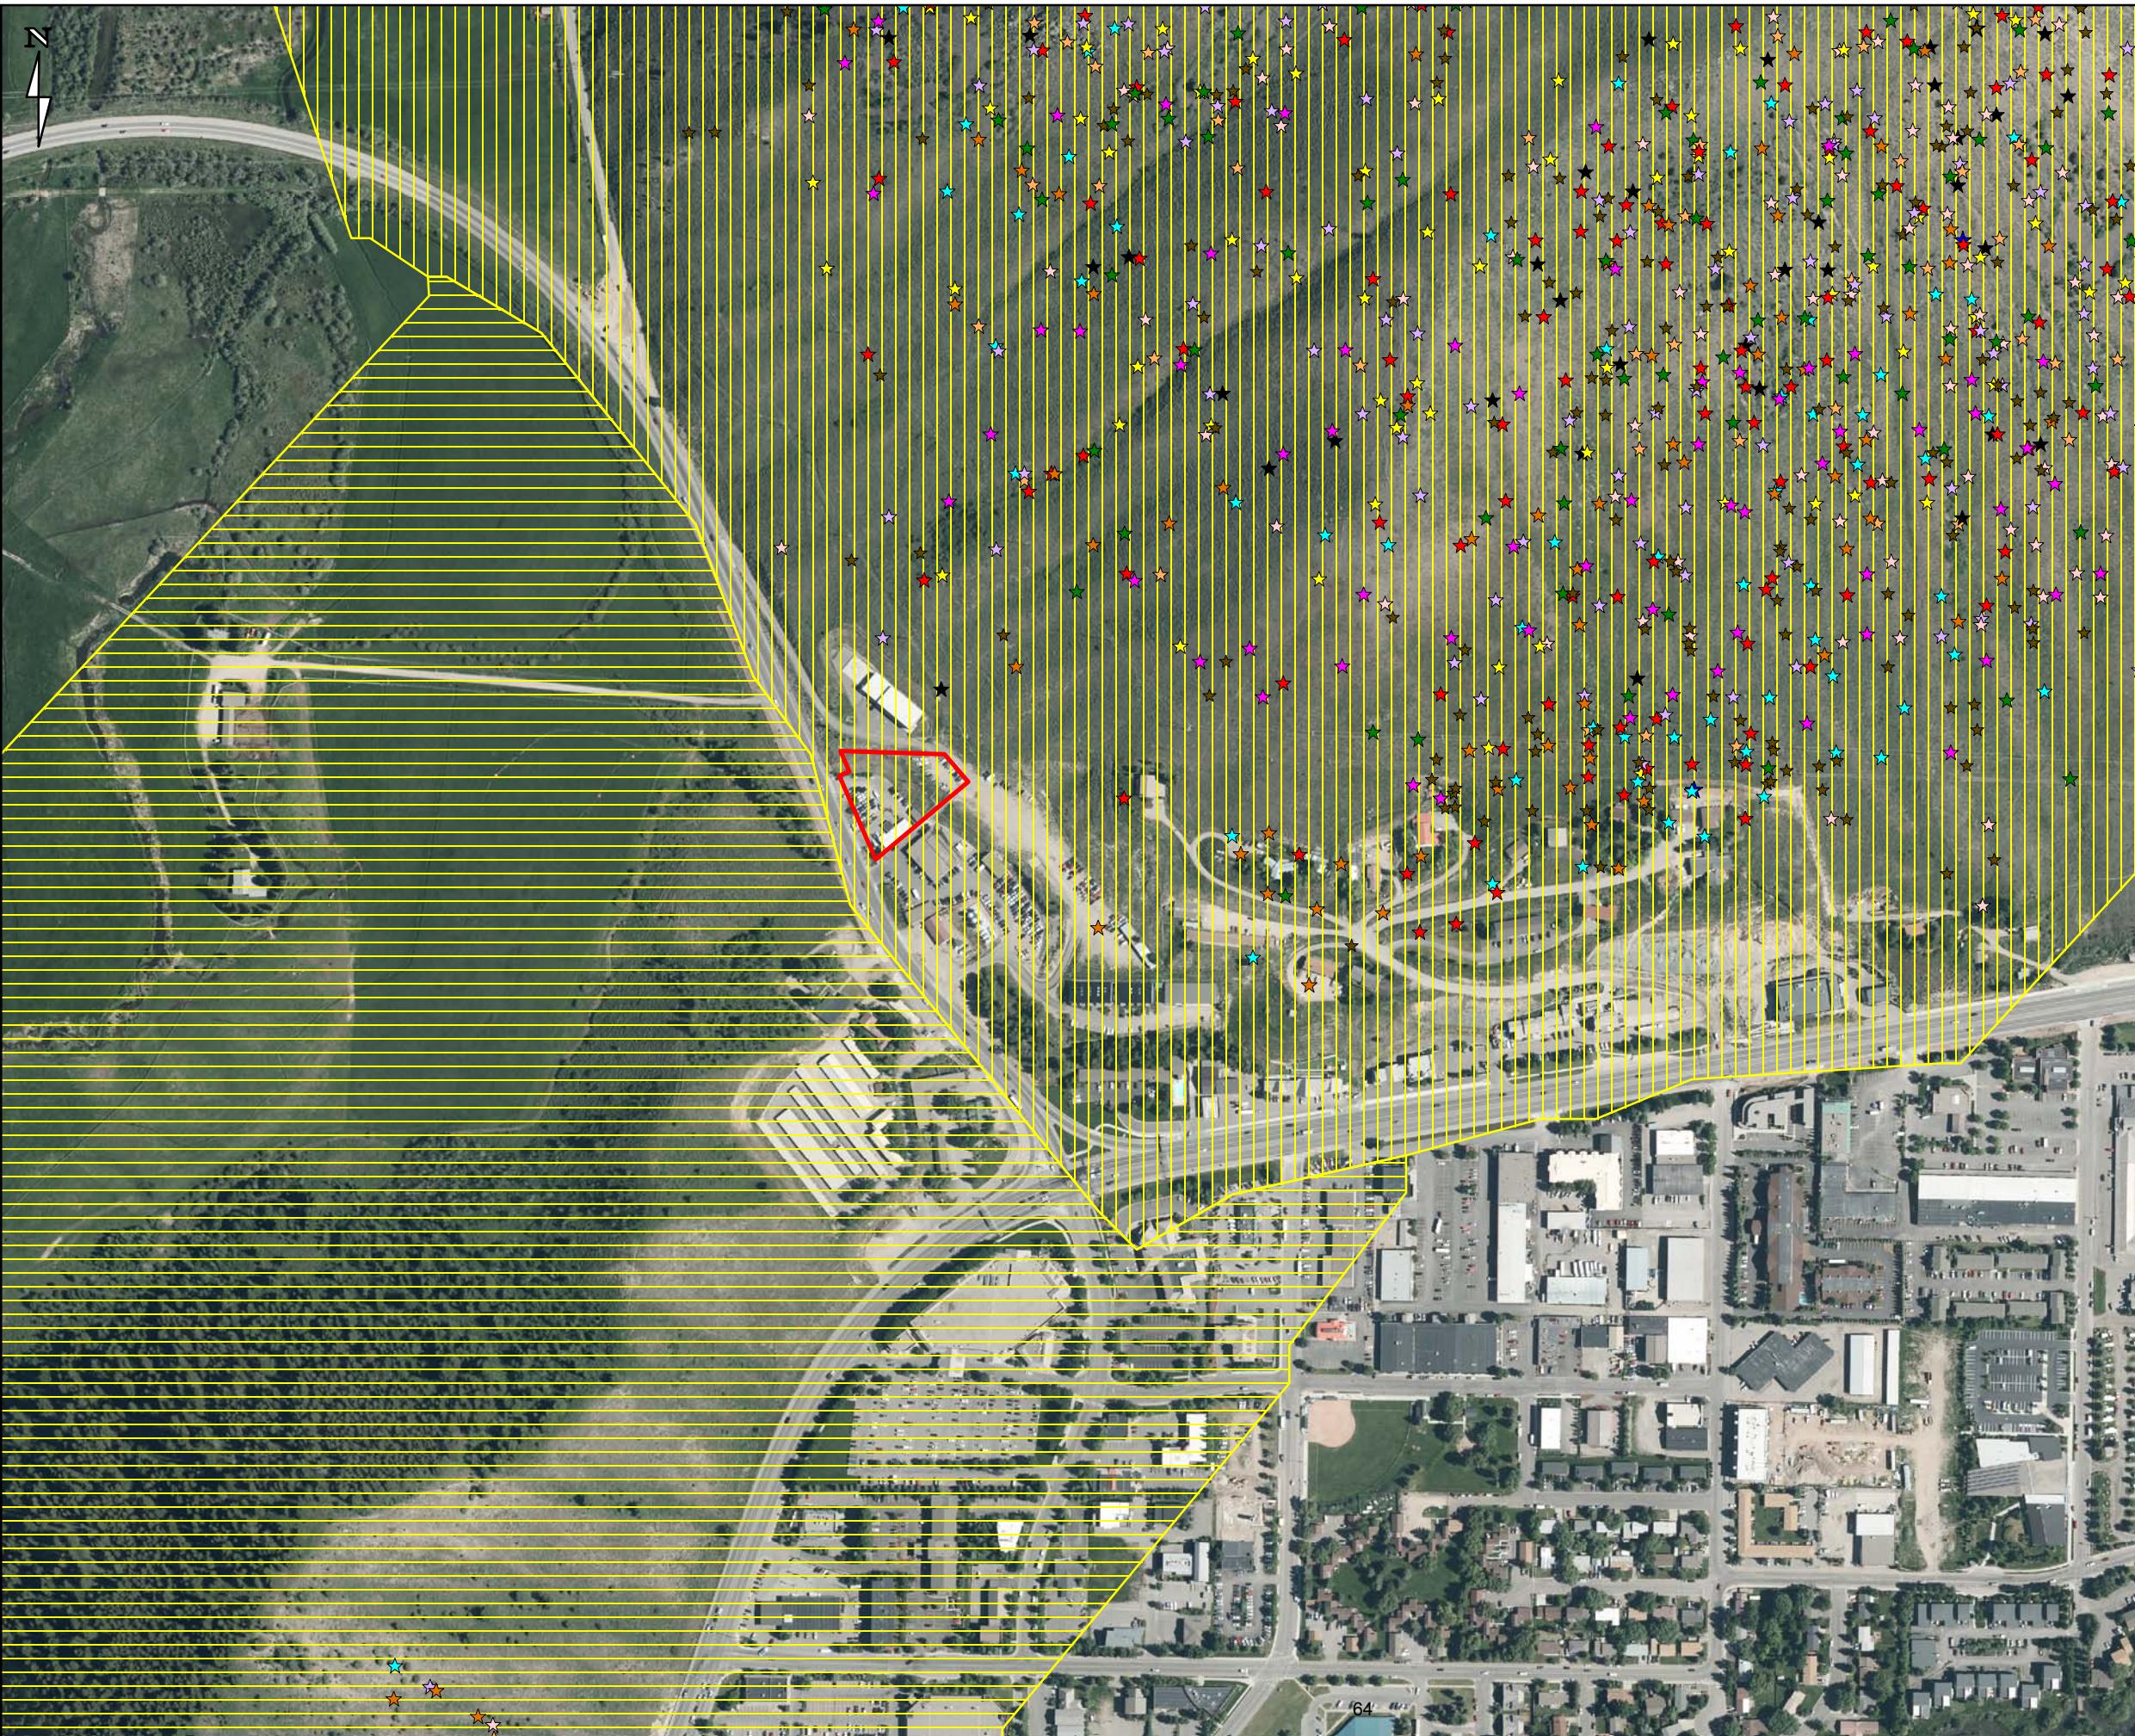
Attachment 3
Aerial photograph depicting mapped mule deer habitat and historic observations on and in the vicinity of the Westview Town Homes property in Jackson, Teton County, Wyoming.

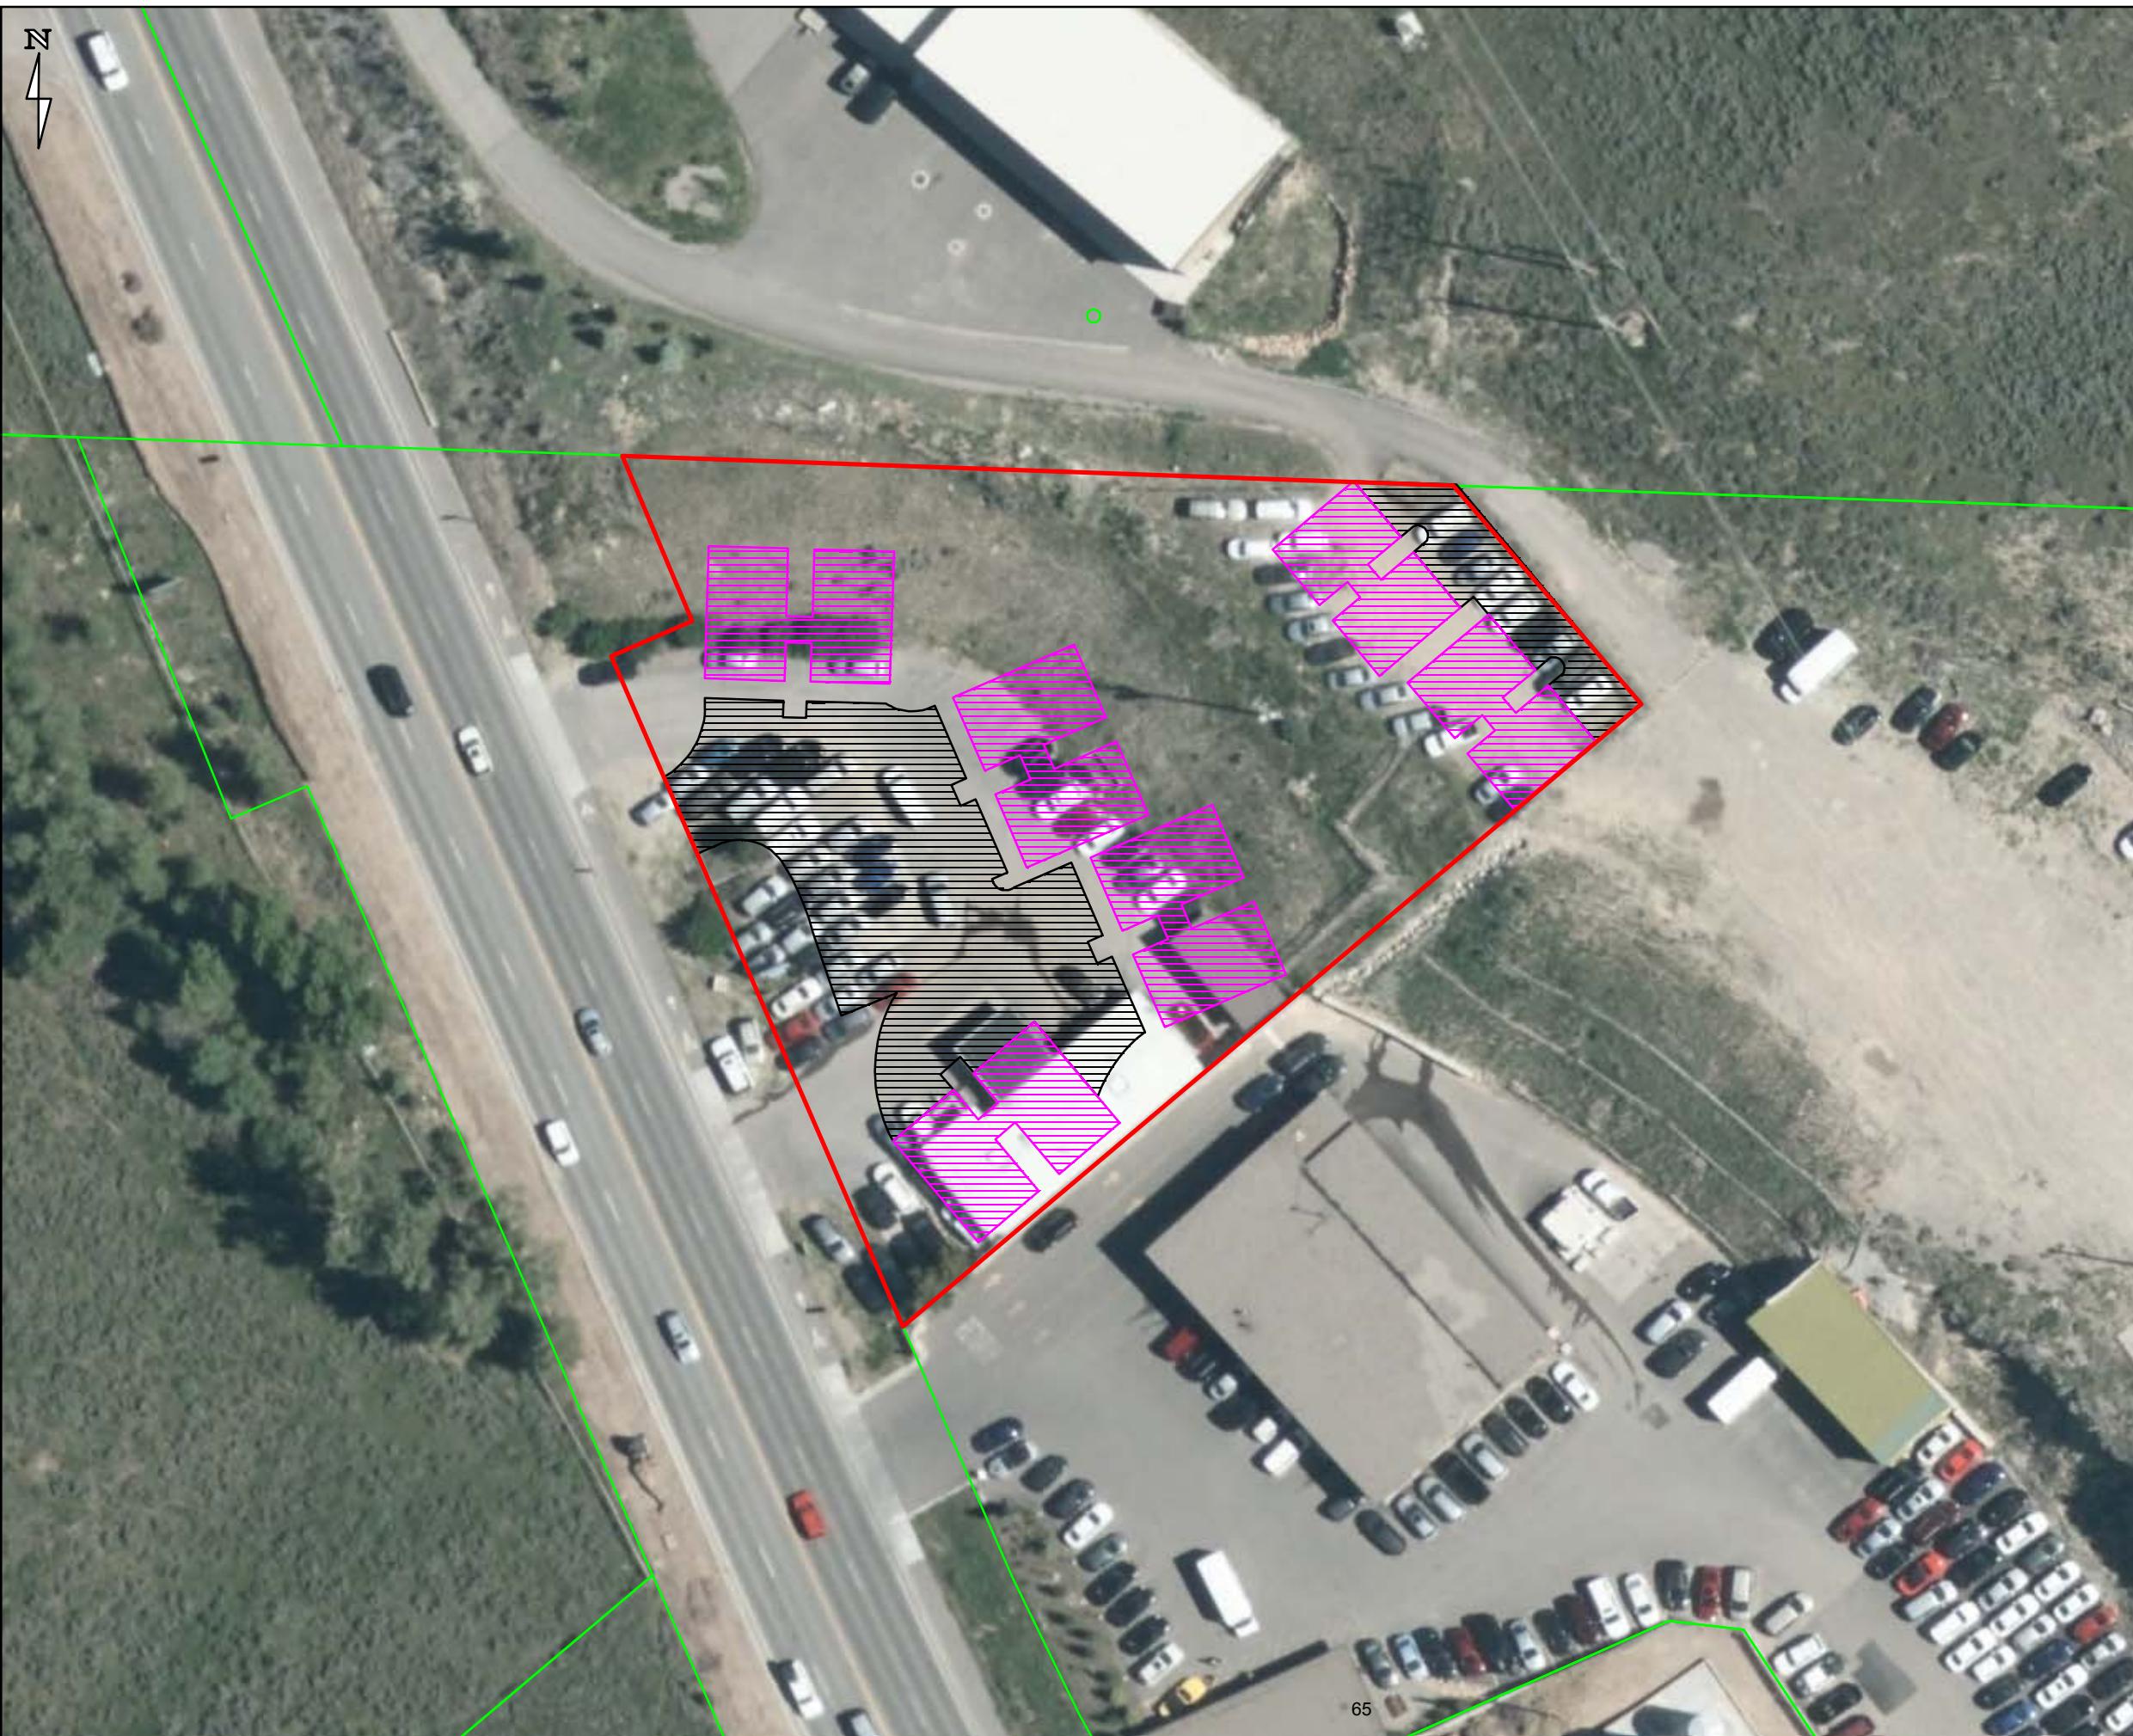
Exhibit 4
Aerial photograph depicting proposed development within the Westview Town Homes property in Jackson, Teton County, Wyoming.

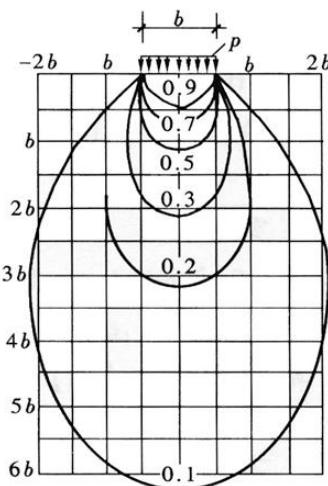
Although assuming foundation pressures induced on underlying soil follow a linear distribution of $0.5H:1V$, often referred to as the "2:1 Method", it is not the only approach to estimate pressures applied to soil by foundation elements. Boussinesq stress distributions, based on elasticity theory, have more of a "bulb" shape. The figure below shows the pressure distributions for a strip footing of width = b . As is shown in the figure, a pressure equipotential line equivalent to 30% of the foundation pressure ($0.3p$) extends to an approximate depth of $2b$, commonly referred to as the foundation's "zone of influence", and only extends laterally to approximately $0.75b$ from the center of the footing. Therefore, in our opinion, requiring the excavation to extend the lateral distances suggested by LT is not necessary.

Figure 1: Boussinesq Vertical Stress Distribution below Continuous Footing

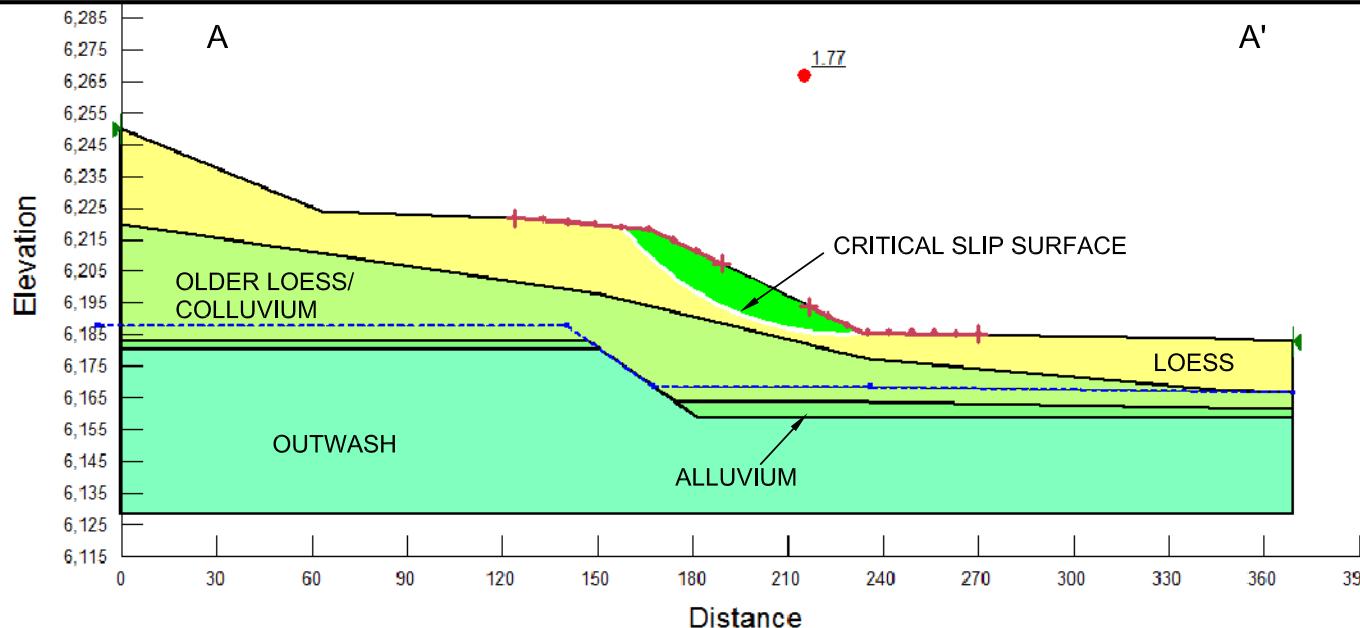
Cross-Section A-A' Existing Conditions - Static Analysis

The slope stability analyses were performed using the SLOPE/W stability module of GeoStudio 2012 version 8.15.1.11236, produced by GEO-SLOPE International, Ltd. The Morgenstern-Price limit equilibrium method, which takes into consideration moment and force equilibrium, was used to analyze slope stability. Schematic cross-sections are shown on Figures 3 and 4 and SLOPE/W output figures are presented in Figures 6 through 9.

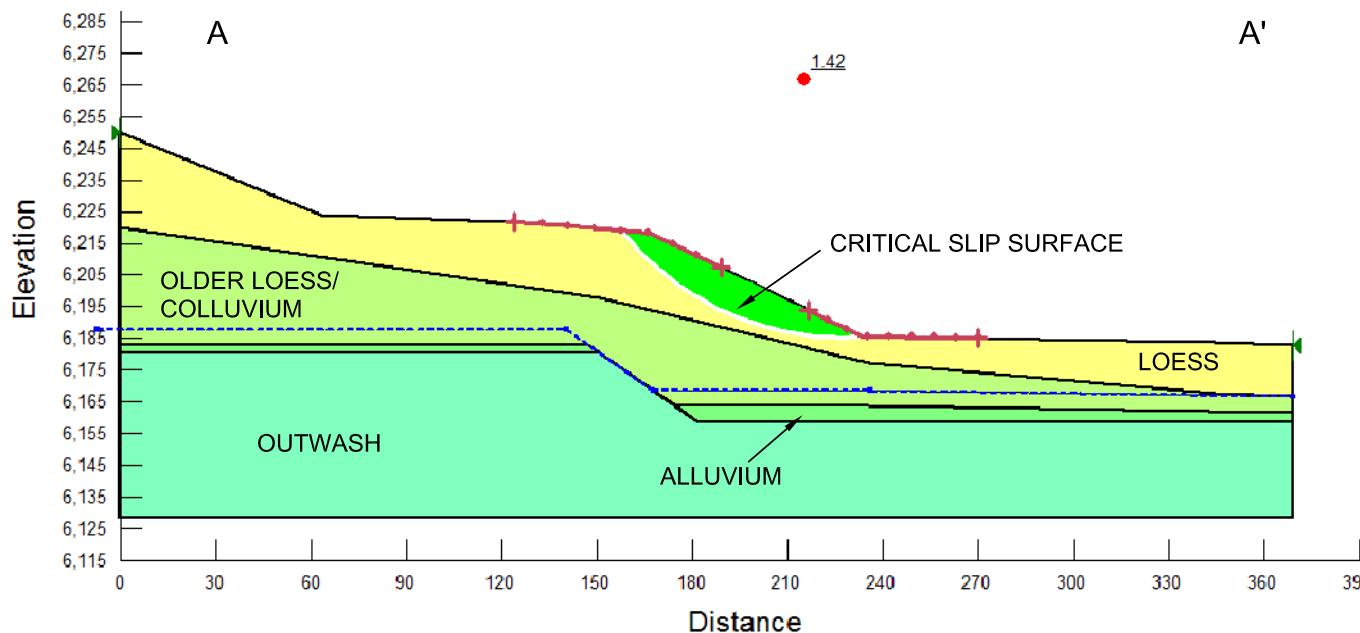
Cross-Section A-A' Existing Conditions - Seismic Analysis

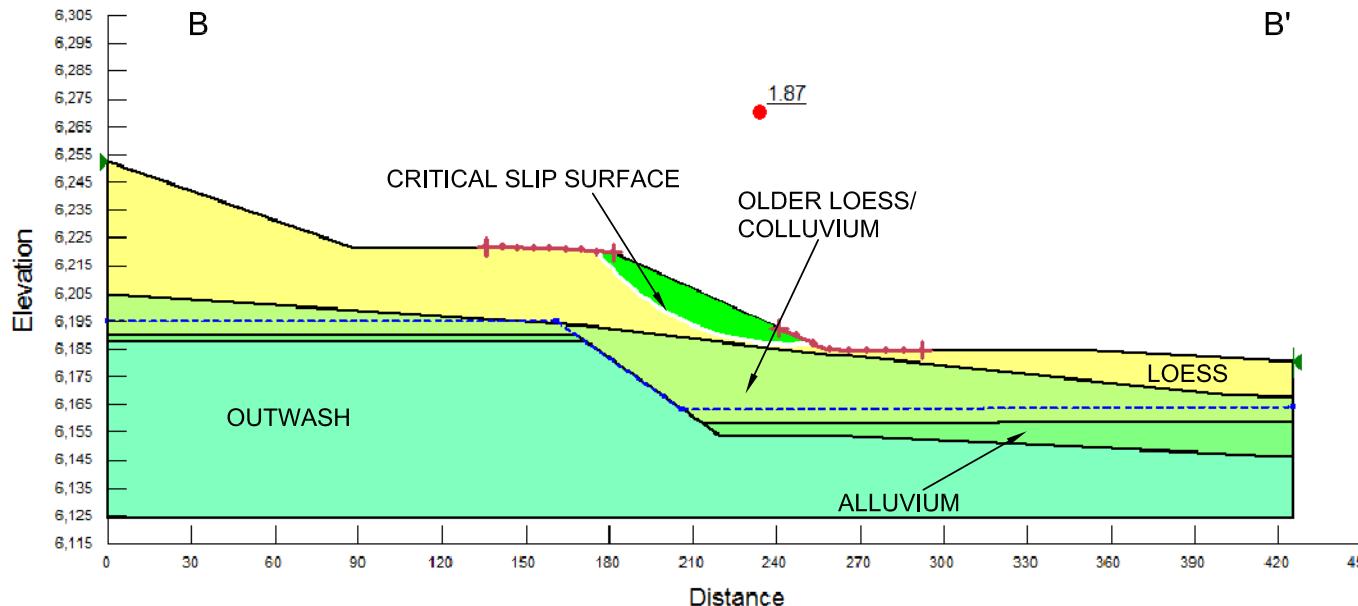
Cross-Section B-B' Existing Conditions - Static Analysis

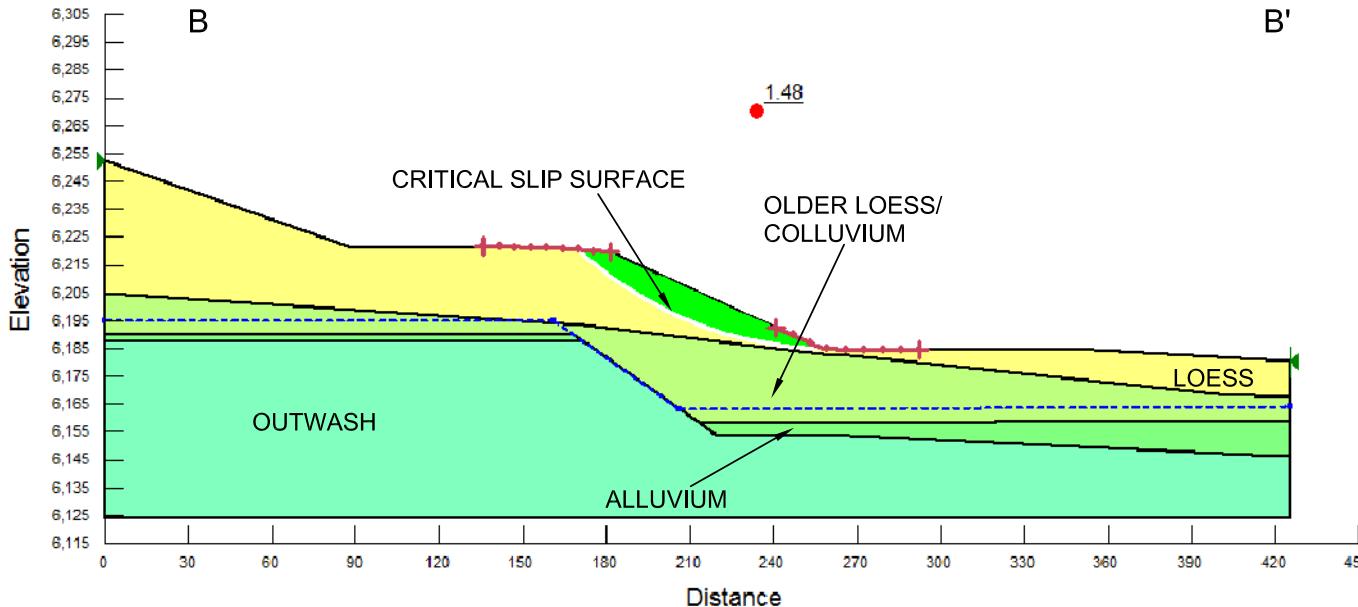
Cross-Section B-B' Existing Conditions - Seismic Analysis

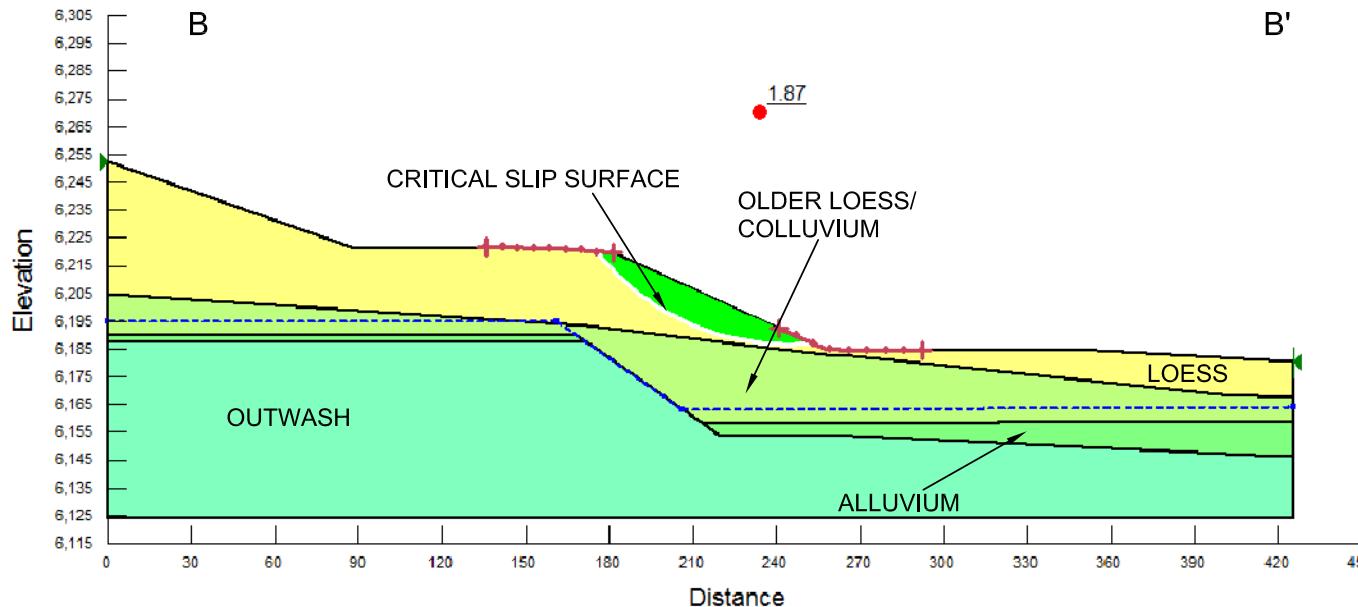
Cross-Section B-B' Existing Conditions - Static Analysis

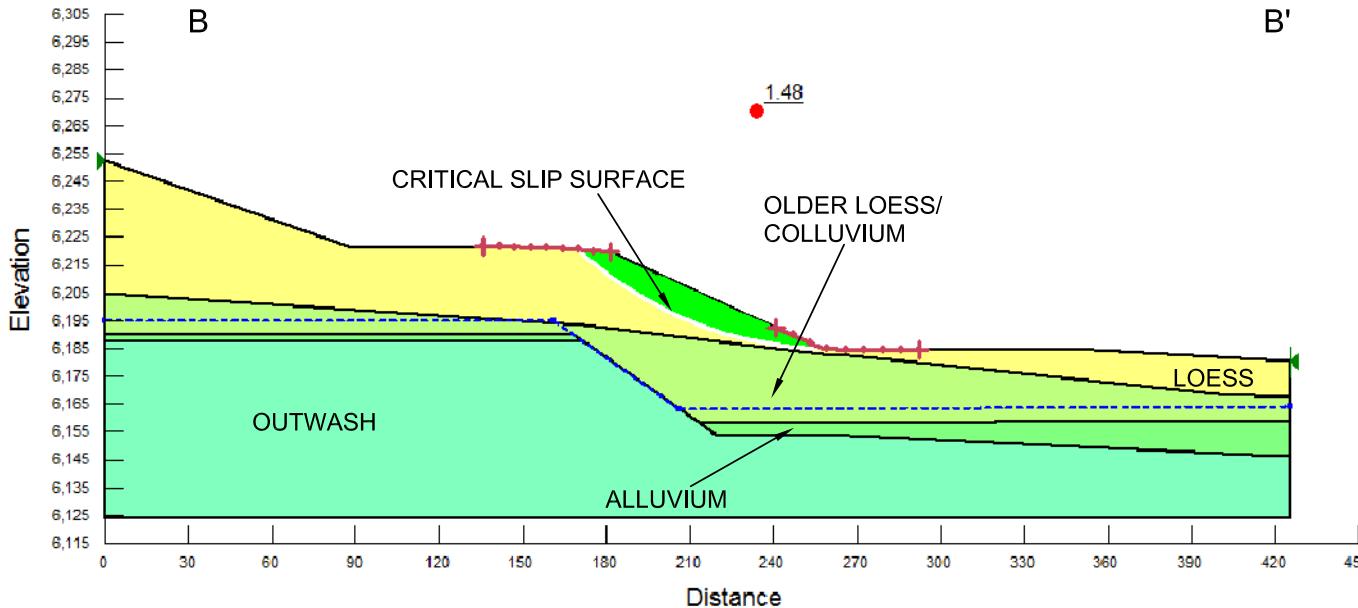
Cross-Section B-B' Existing Conditions - Seismic Analysis

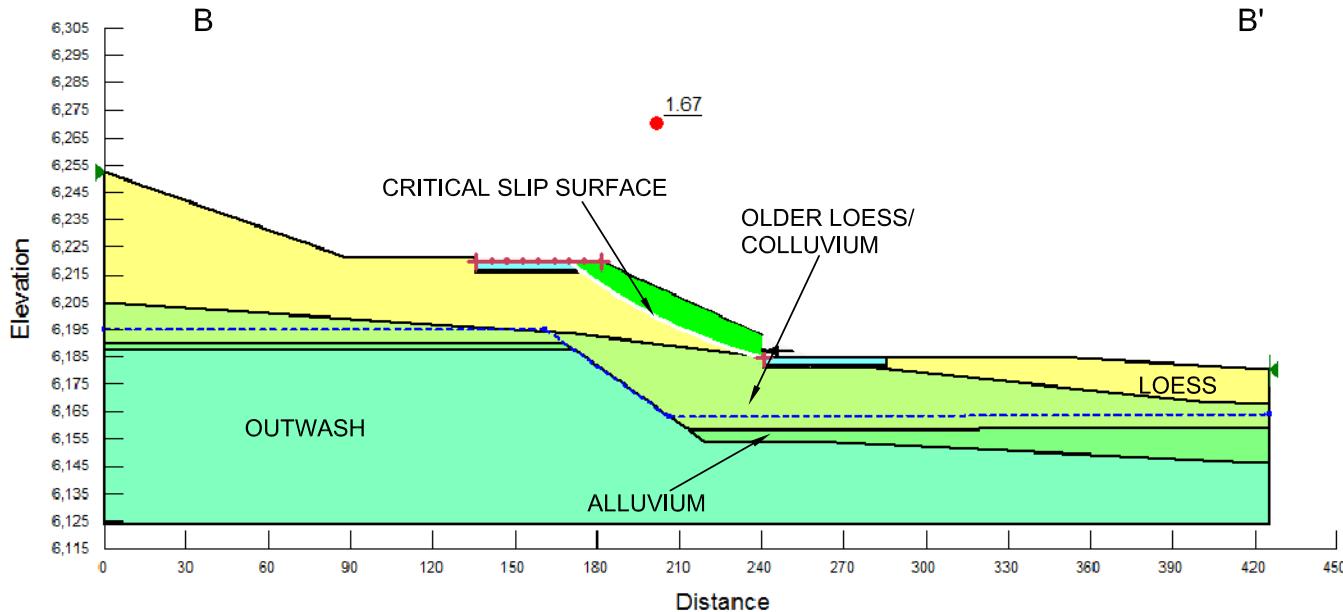
Cross-Section B-B' Post-Construction Conditions - Static Analysis

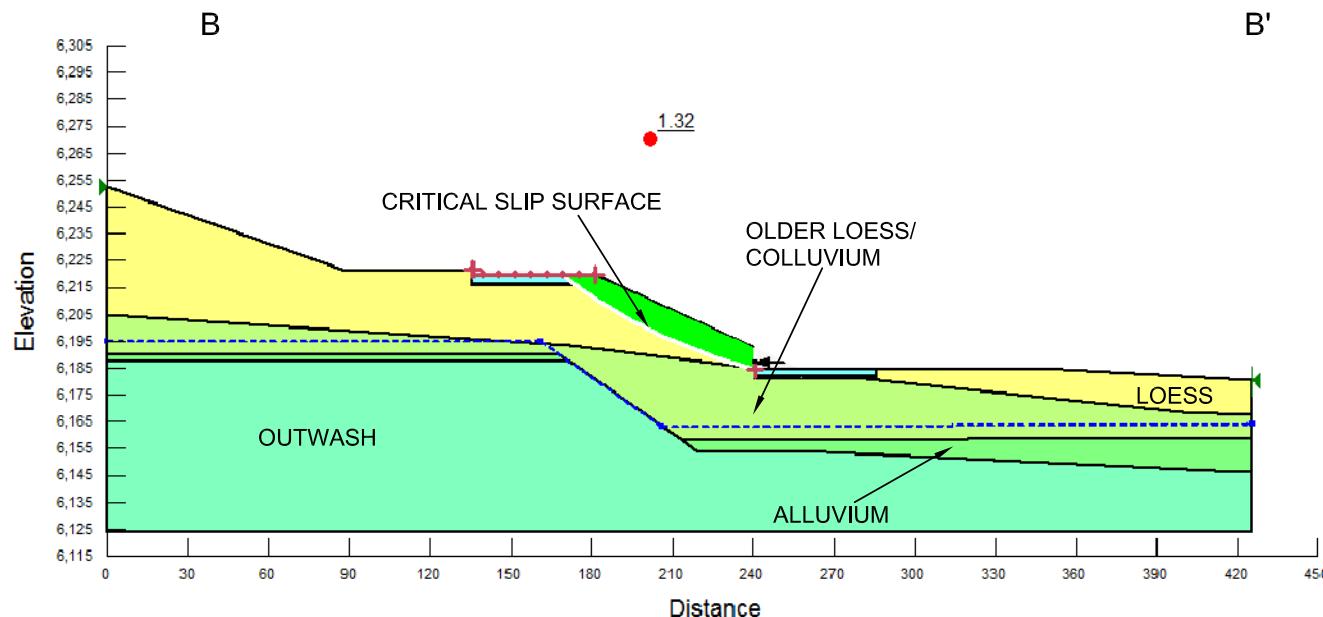
Cross-Section B-B' Post-Construction Conditions - Seismic Analysis

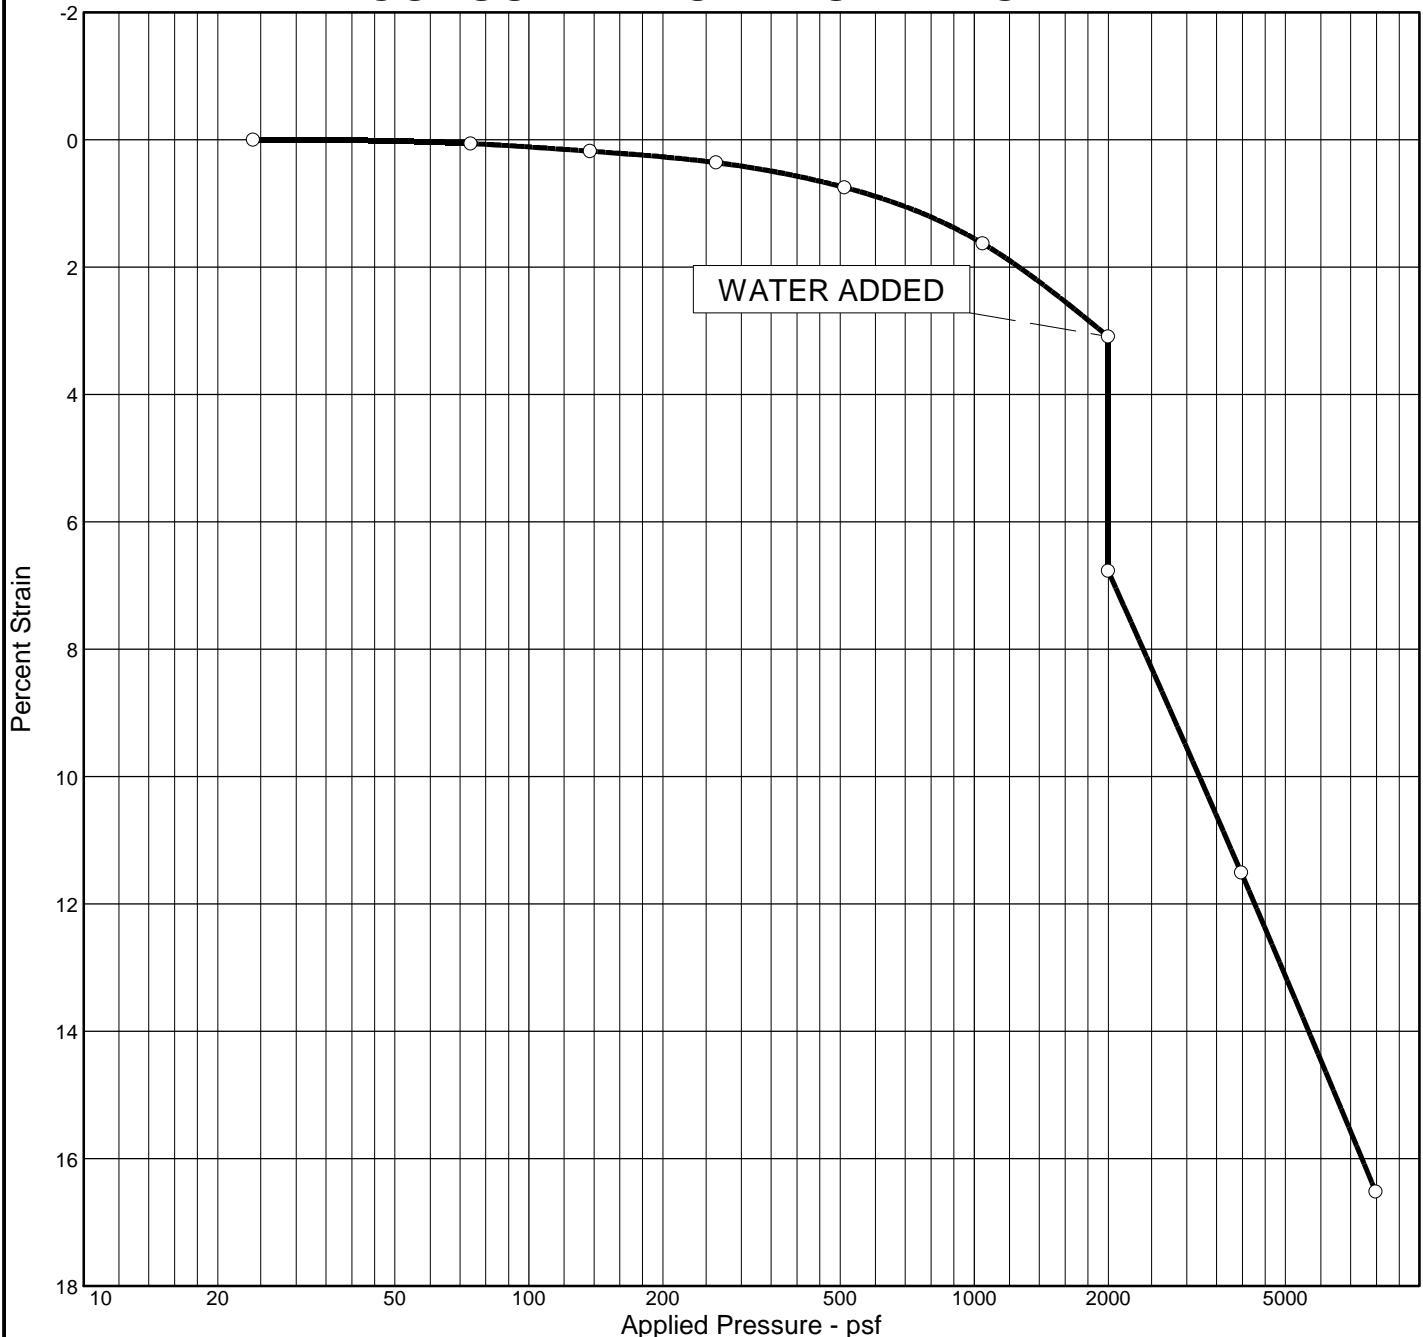
CONSOLIDATION TEST REPORT

Natural		Dry Dens. (pcf)	LL	PI	Sp. Gr.	Overburden (psf)	P_c (psf)	C_c	C_r	Swell Press. (psf)	Clpse. %	e_0
Sat.	Moist.											
41.7 %	22.3 %	68.5			2.65	712	965	0.40			3.7	1.415
