TOWN OF JACKSON

SUBJECT: **ITEMS P18-095, P18-135 & P18-136:** REQUEST FOR AMENDMENT OF DEVELOPMENT PLAN, AMENDMENT TO DEVELOPMENT AGREEMENT & APPROVAL OF A HILLSIDE CONDITIONAL USE PERMIT (CUP) FOR THE WESTVIEW TOWNHOMES ADDRESSED AT 1255 WEST HIGHWAY 22.

**-ENVIRONMENTAL ANALYSIS-
WESTVIEW TOWN HOMES PROJECT,
JACKSON, WYOMING**

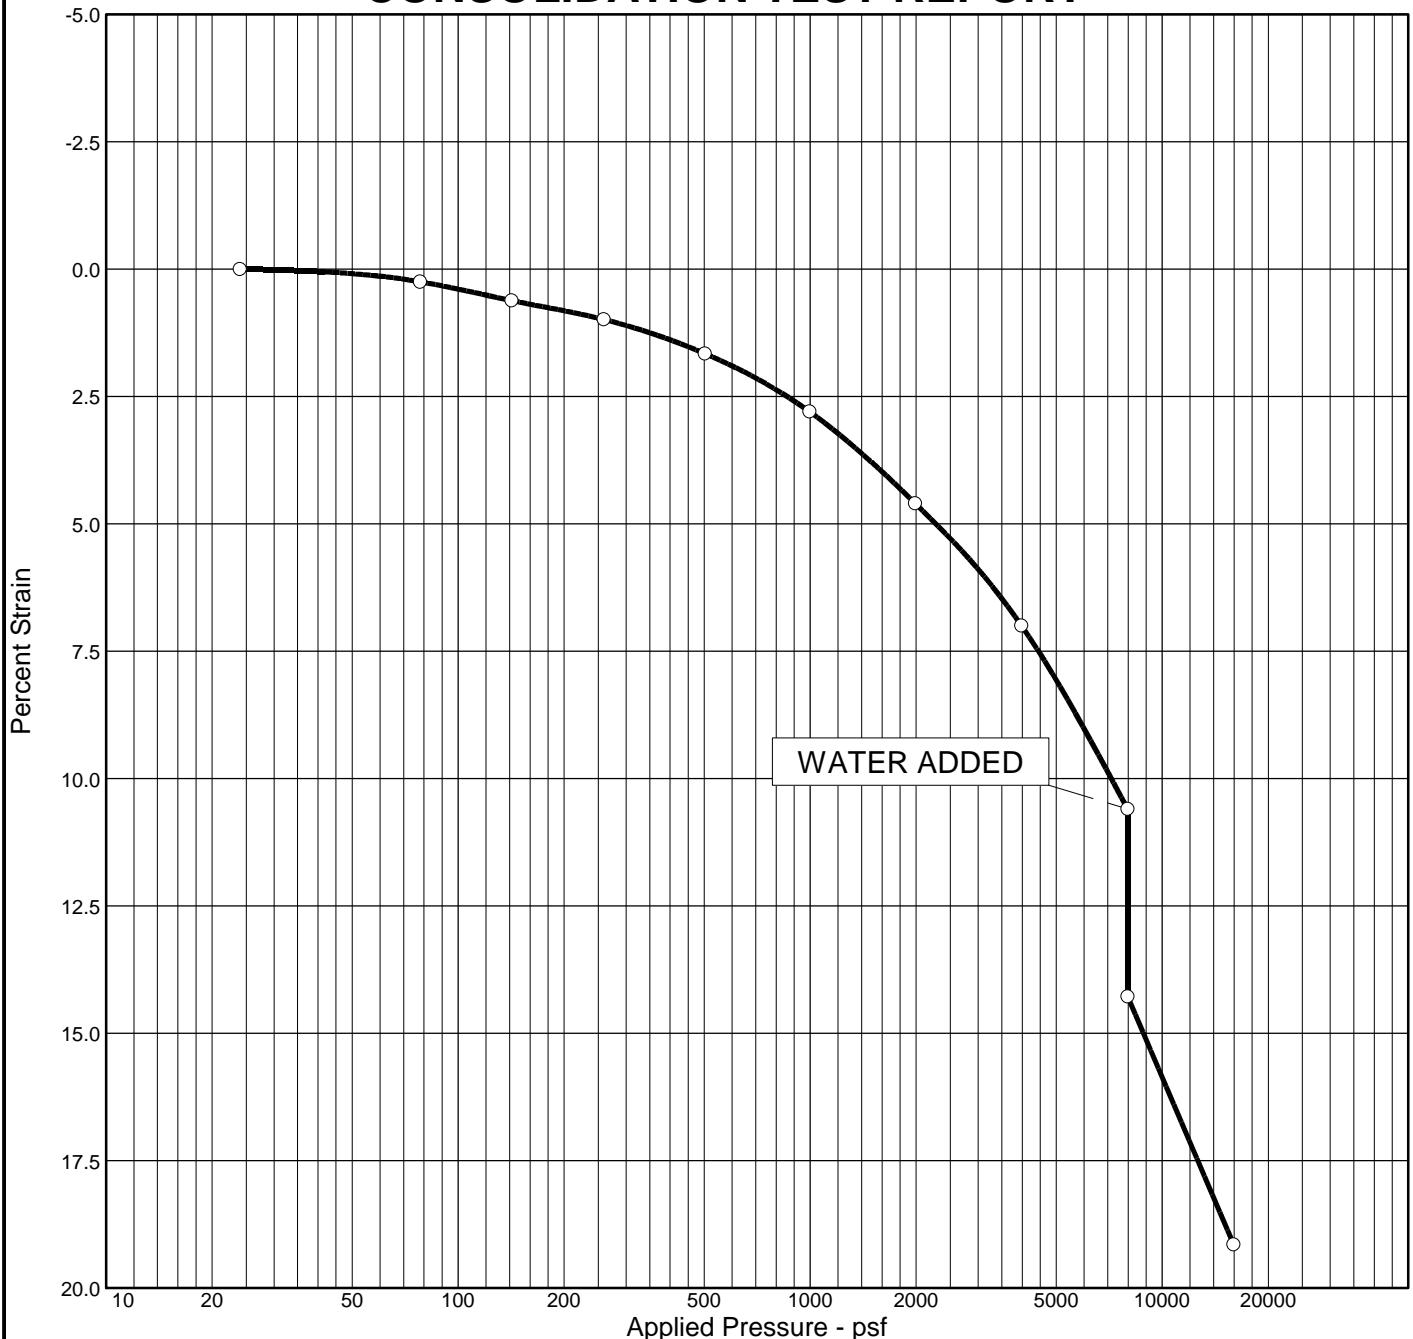
CONSOLIDATION TEST REPORT

Natural		Dry Dens. (pcf)	LL	PI	Sp. Gr.	Overburden (psf)	P_c (psf)	C_c	C_r	Swell Press. (psf)	Clpse. %	e_0
Sat.	Moist.											
32.3 %	13.7 %	77.8			2.65	752	1566	0.34			3.7	1.126

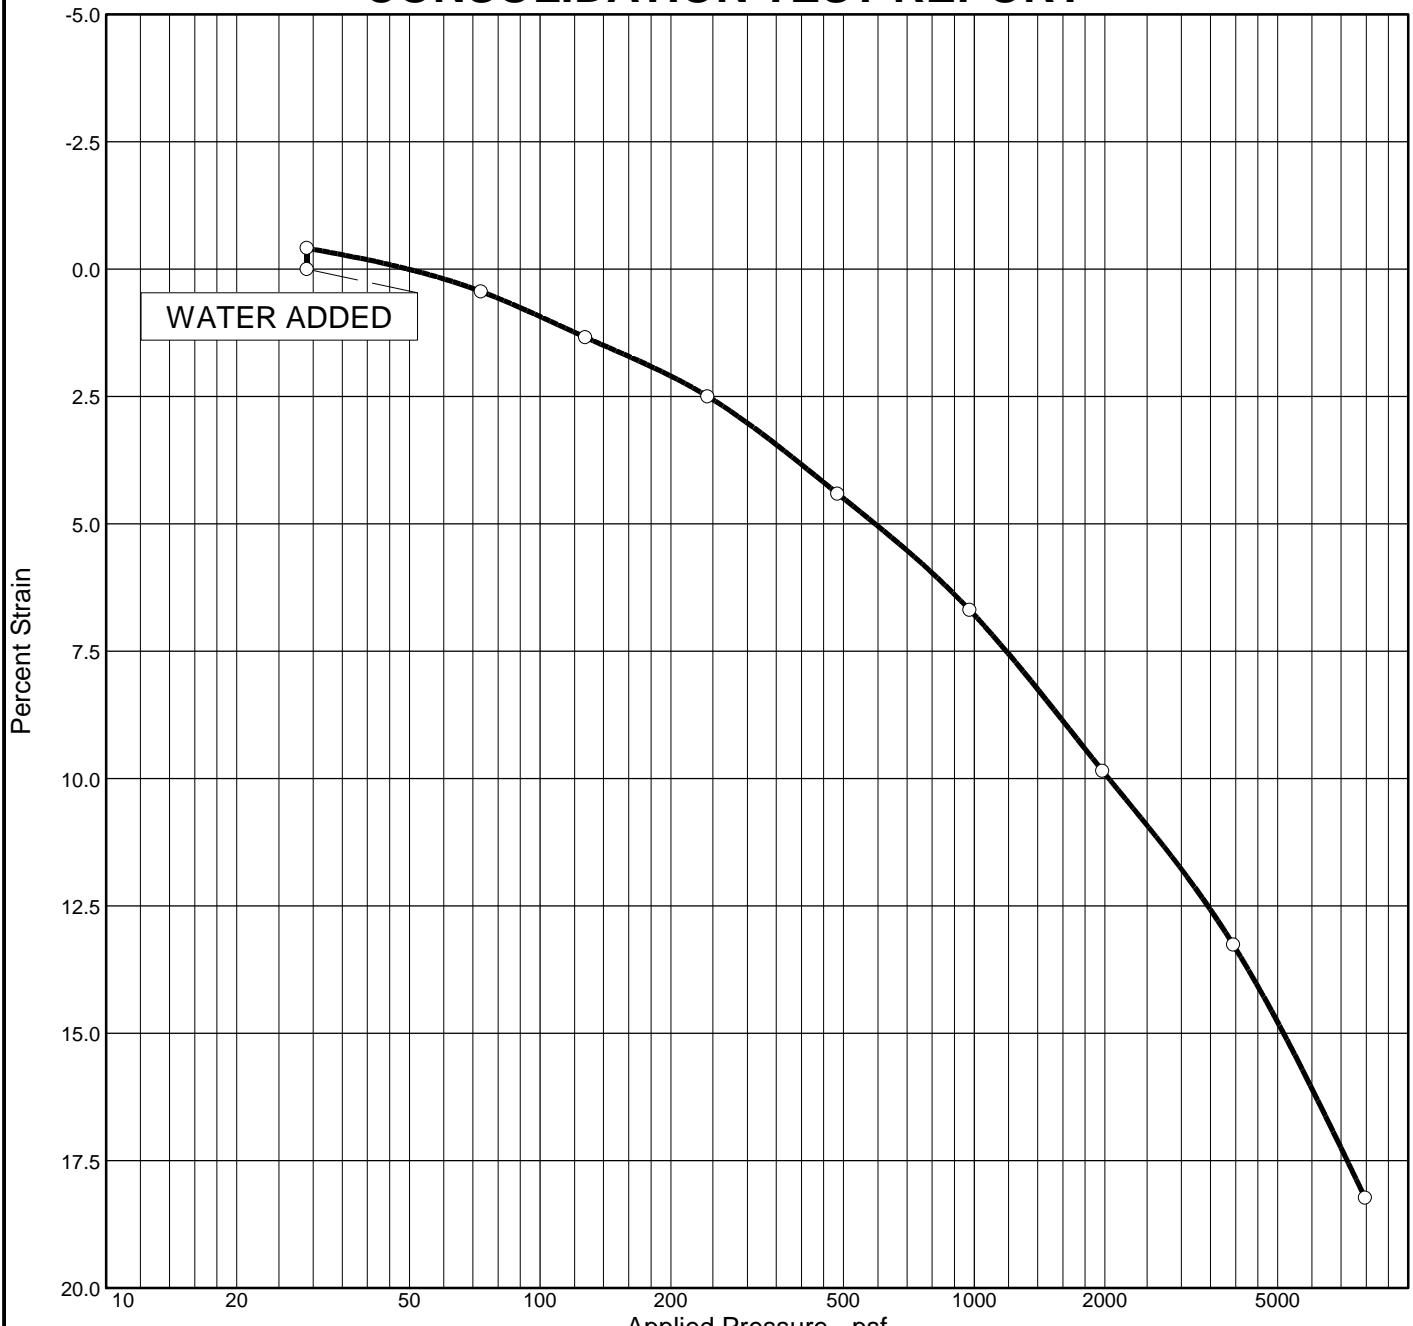
CONSOLIDATION TEST REPORT

Natural		Dry Dens. (pcf)	LL	PI	Sp. Gr.	Overburden (psf)	P_c (psf)	C_c	C_r	Swell Press. (psf)	Swell %	e_0
Sat.	Moist.											
30.2 %	14.4 %	73.1			2.65	920	1475	0.38		50	0.4	1.262

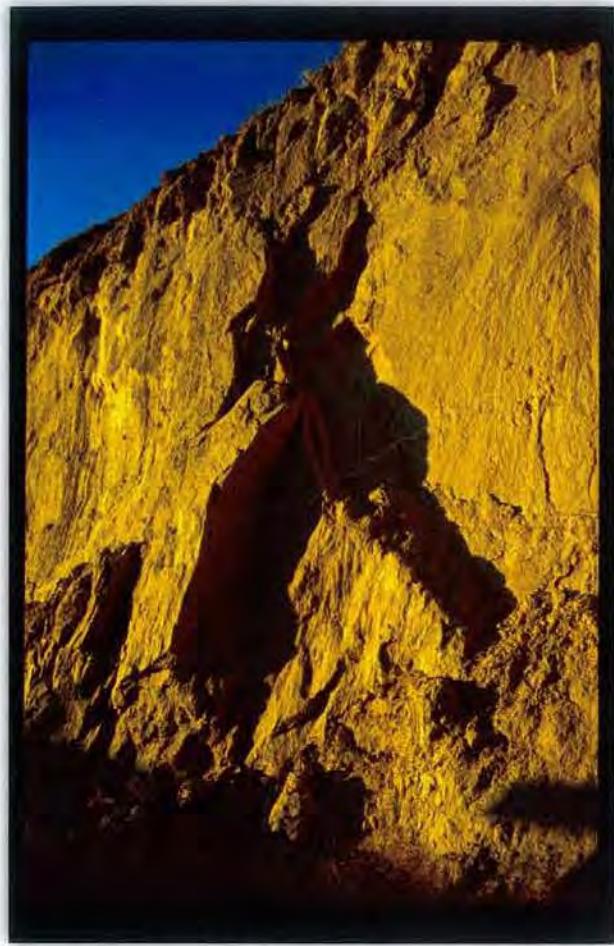
Figure 1. Near-vertical loess bluff face.

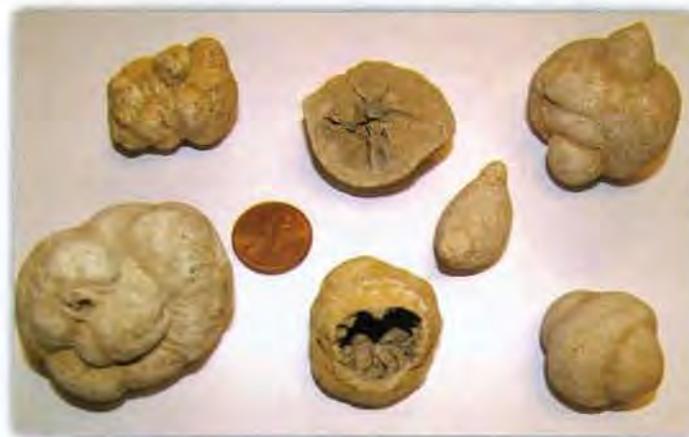
Figure 3. Loess "kindchen."

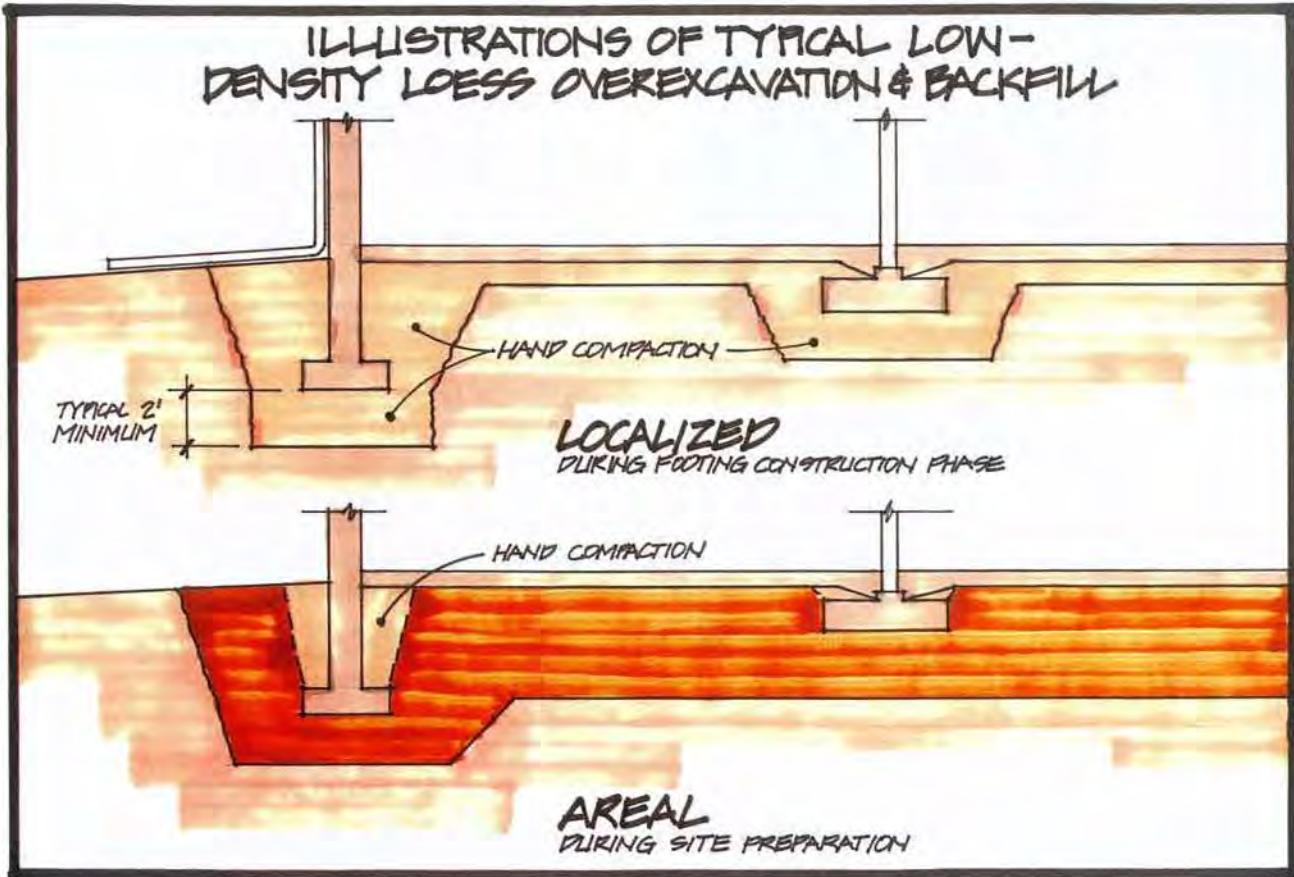
Figure 6. Cross-sections illustrating the partial excavation concept.

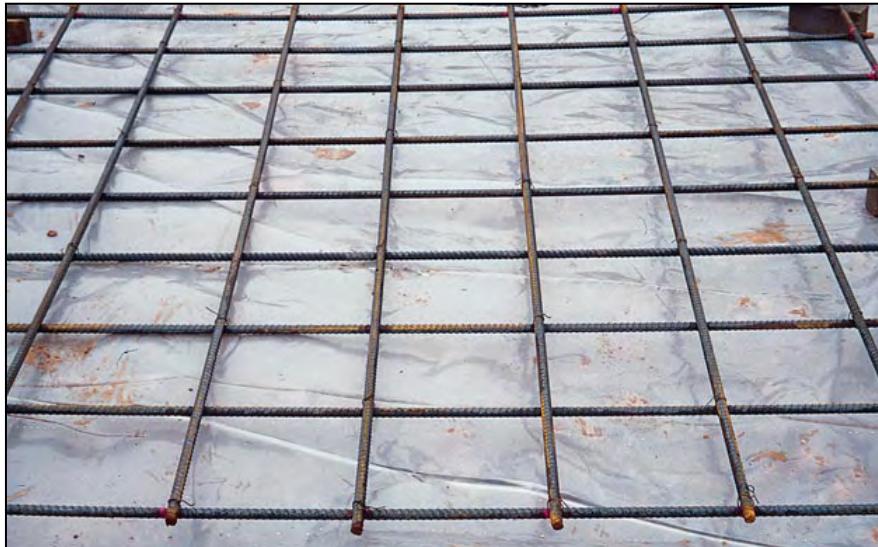
Rebar in concrete slabs placed directly on a vapor retarder help to control slab curling and cracking. Use supported deformed bars no smaller than #4, and space the bars far enough apart so workers can step between them.

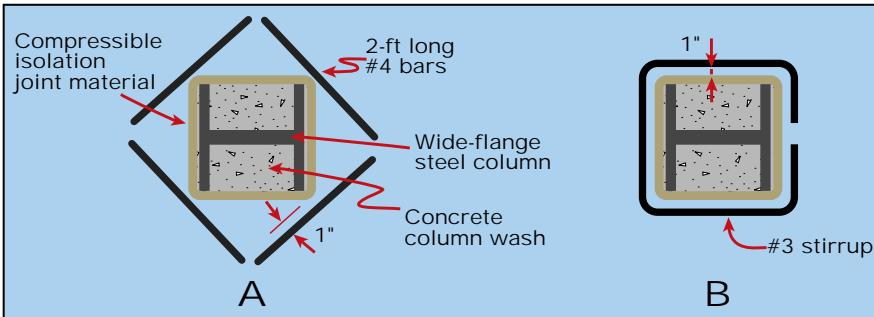
Eliminate the normal isolation-joint box outs at wide-flange steel columns by wrapping the column with compressible material and using 2-foot lengths of #4 bars (A) to control cracking at the reentrant corners. To speed up steel placement at the columns, have the rebar supplier fabricate continuous #3 stirrups that workers can easily bend open to fit around the column (B). In either case, the steel should be positioned with a top-and-side clear cover of 1 inch.

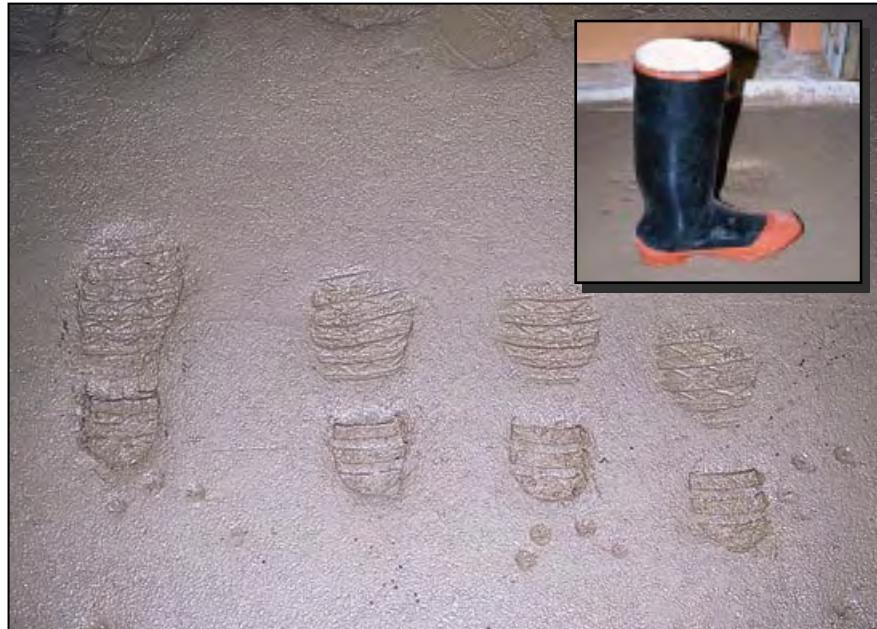
Figure 1. Concrete is generally considered to be ready for floating when finishers leave a ¼-inch-deep footprint in the surface. Using a boot filled with steel shot (inset) to produce footprints, we found that 2½-inch-slump concrete placed on a stone base was ready for floating about 45 minutes earlier than the same concrete placed directly on a vapor retarder.

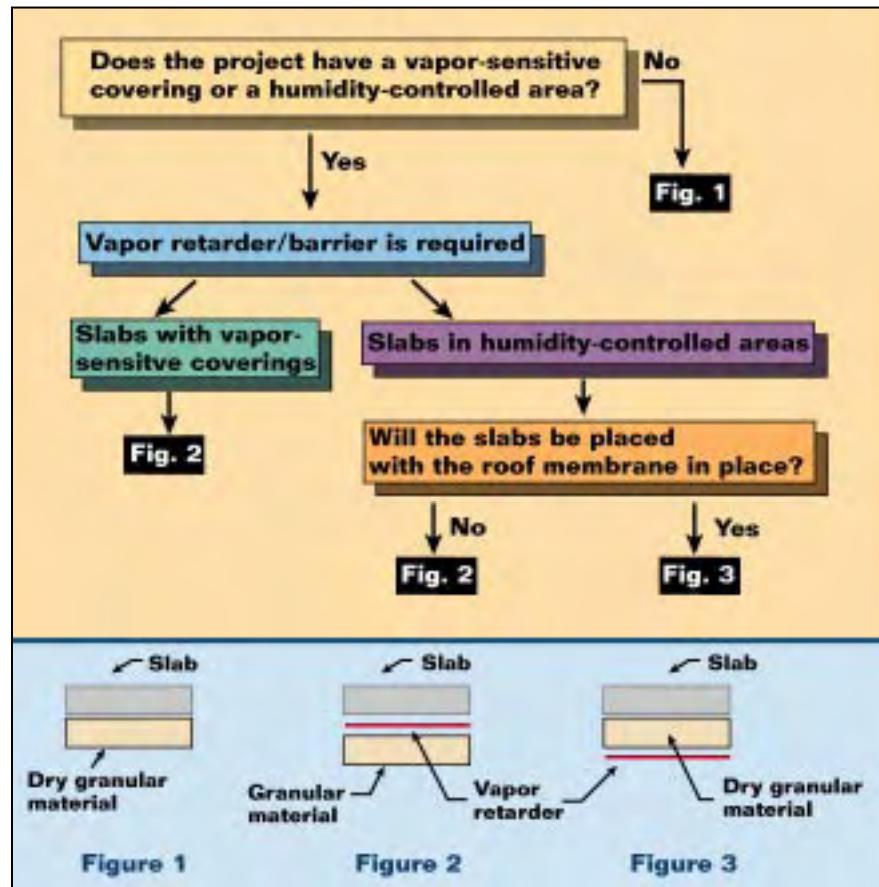
Figure 2. This flow chart helps designers decide if a vapor retarder or barrier is needed and where it should be placed.

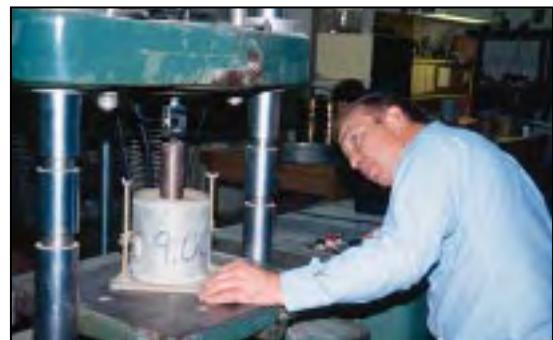
Figure 1. A technician applies load to a compacted soil specimen in a CBR mold. Specimens were loaded with and without sand layers to determine the effect of differing sand-layer thicknesses.

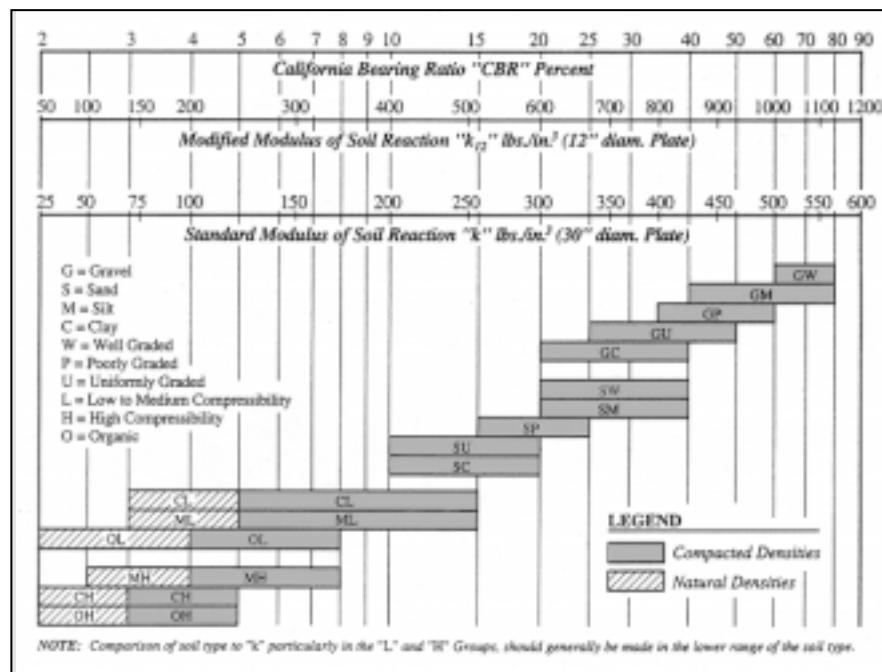
Figure 2. Interrelationships of CBR, k-values and soil classification (from Ref. 2).

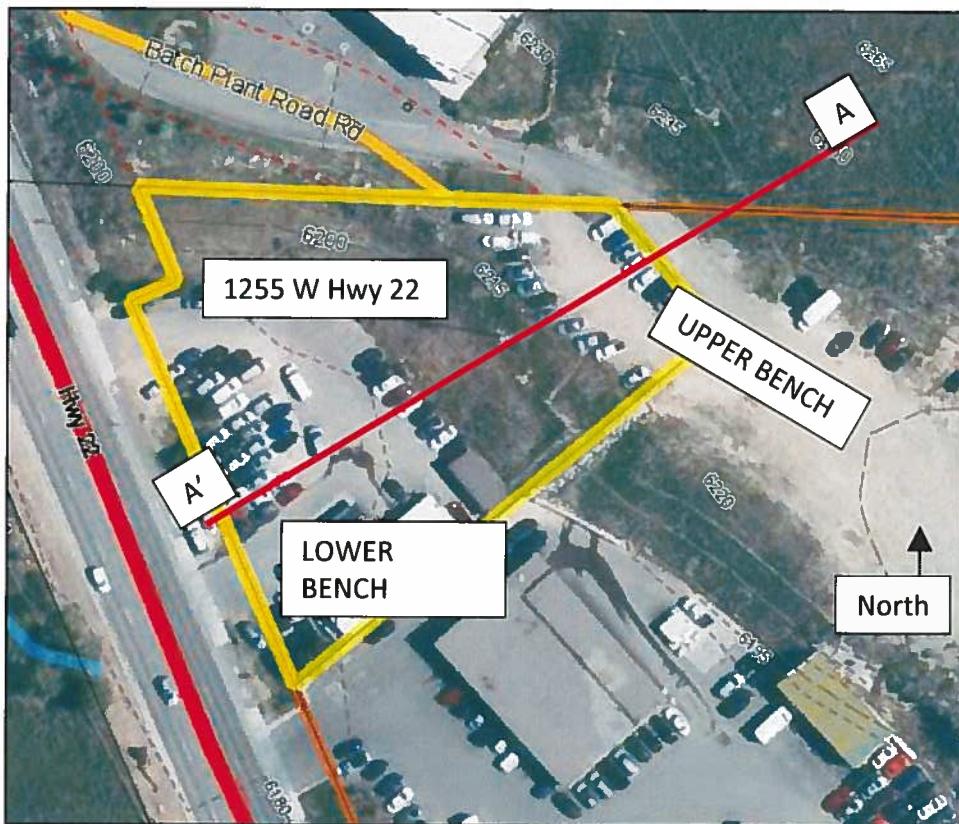
Figure 1: Site Plan and Cross Section Location Map

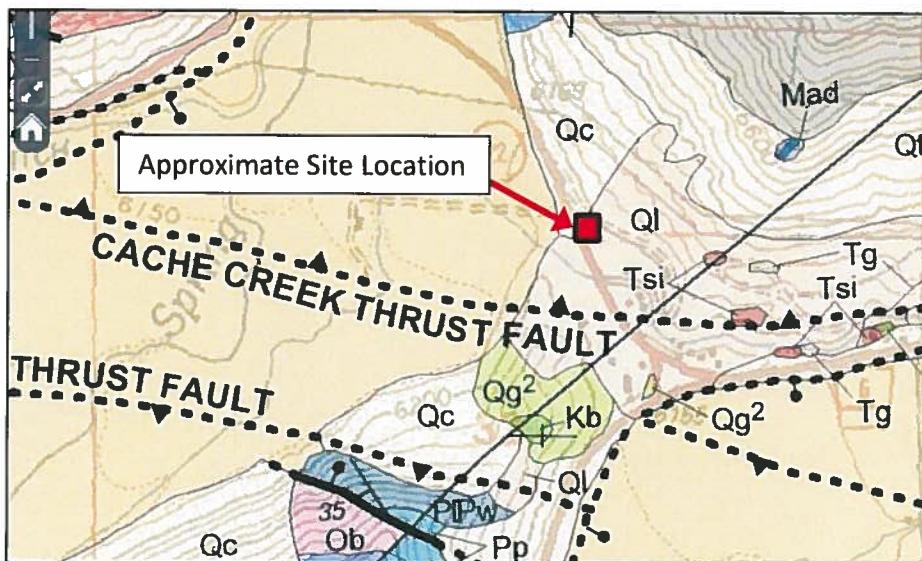
Figure 2: Geologic Map (Love, 2003)

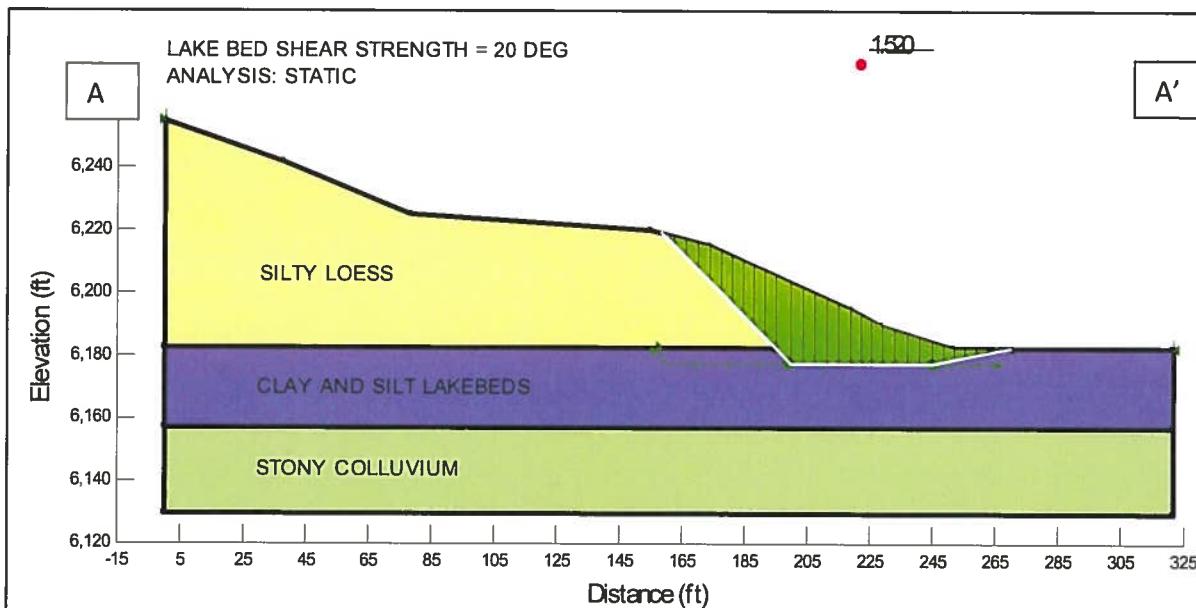
Figure 3: Lower Bound (Residual) Strength of Lakebed Soil - 20°, Static Analysis

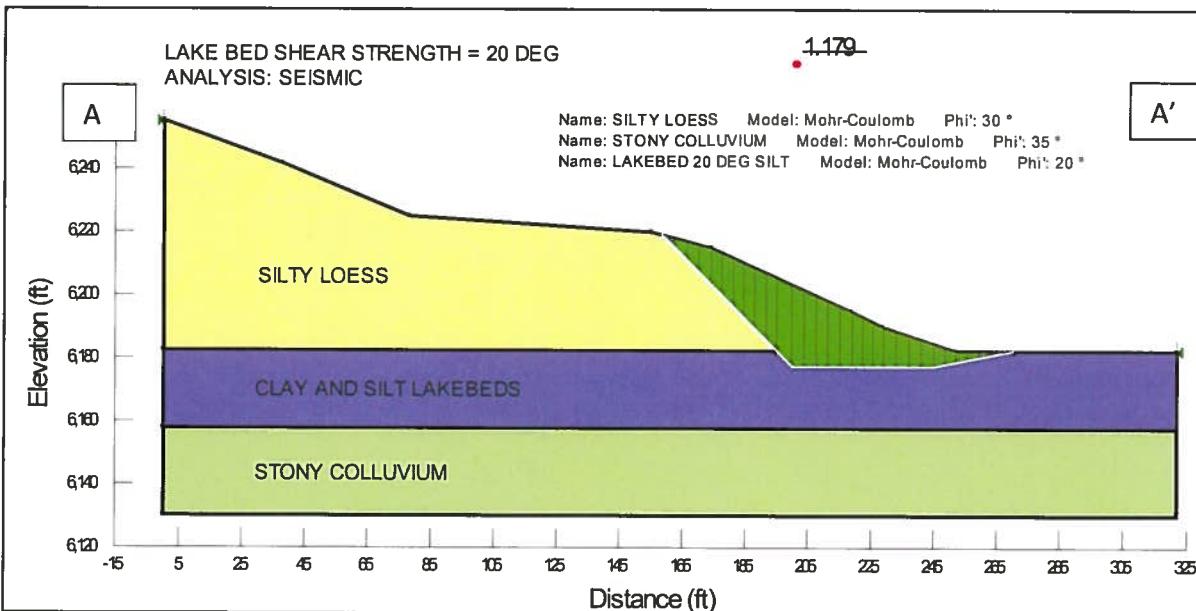
Figure 4: Lower Bound (Residual) Strength of Lakebed Soil - 20°, Seismic Analysis

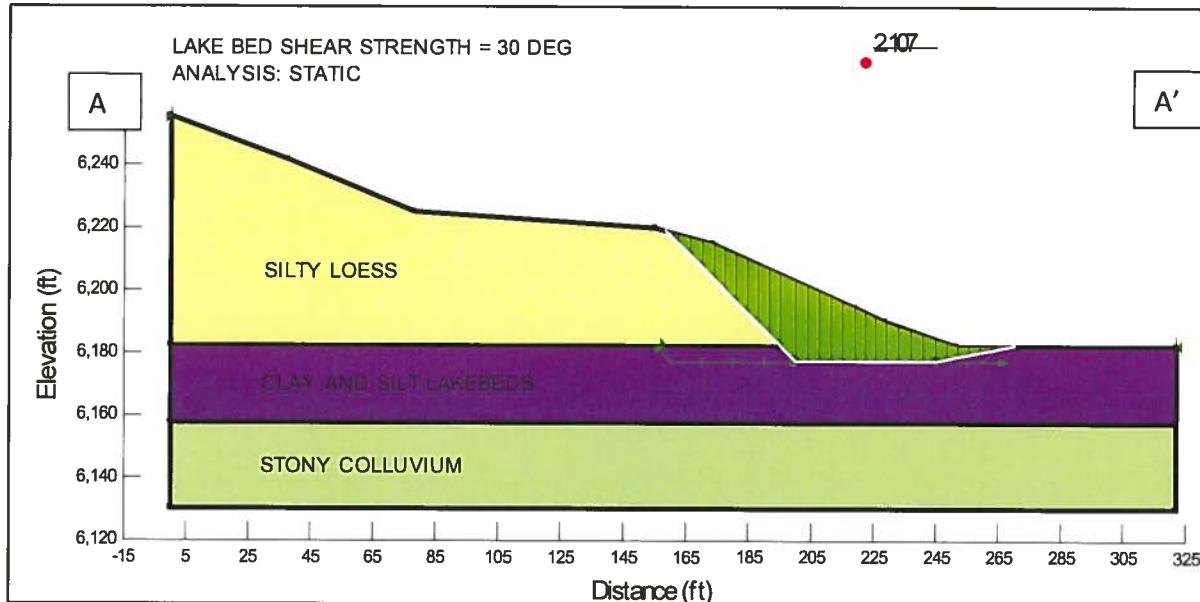
Figure 5: Upper Bound (Peak) Strength of Lakebed Soil - 30°, Static Analysis

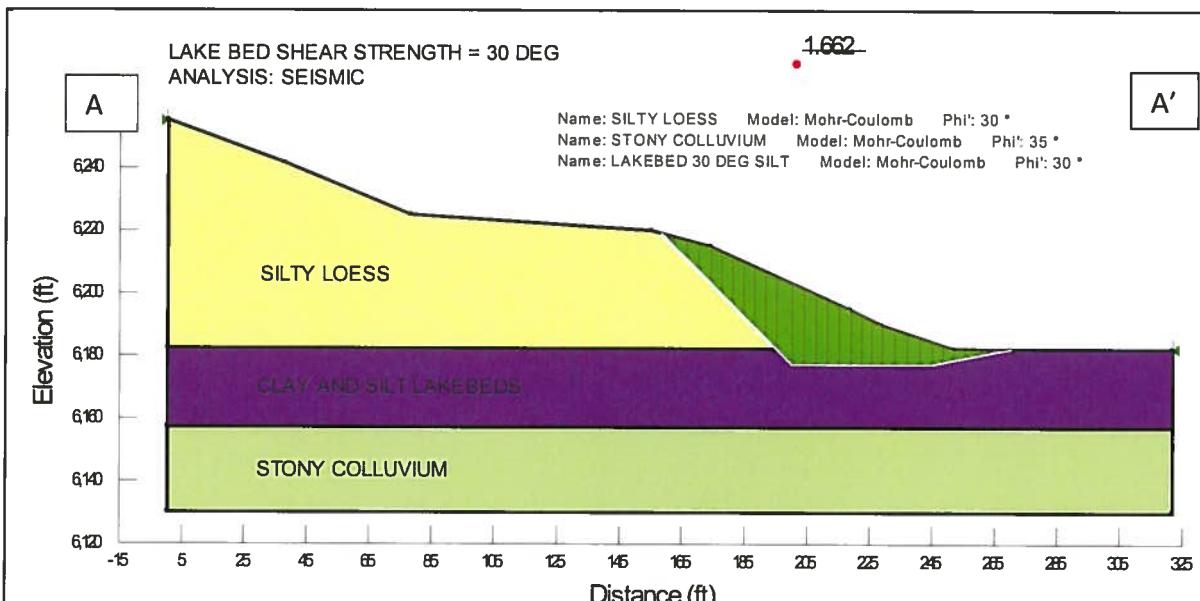
Figure 6: Upper Bound (Peak) Strength of Lakebed Soil - 30°, Seismic Analysis
